Status of the Forward Tagger

Amanda Hoebel

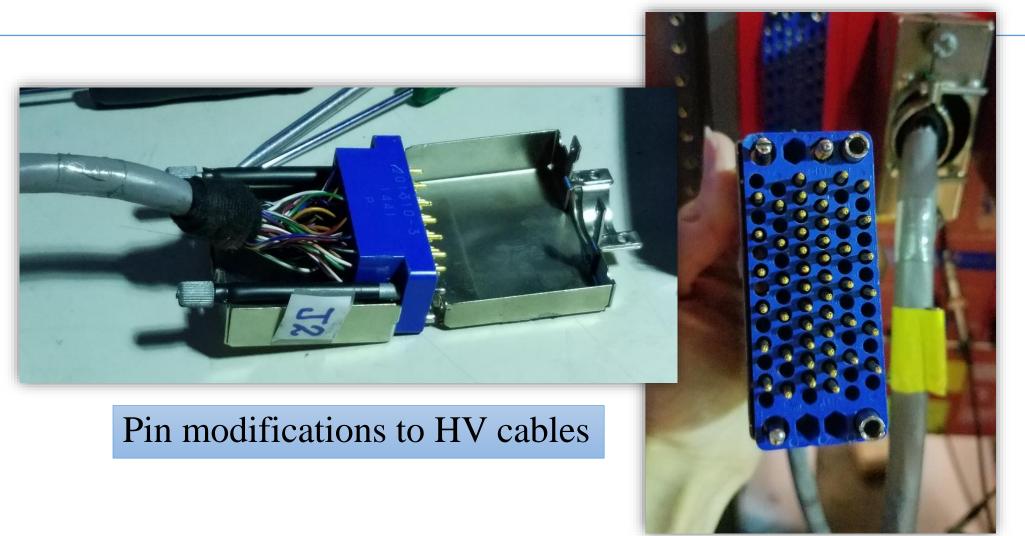
- Pins added to HV cable to allow for interlocks.
 - \circ Pins 79 and 80 added to enable interlocks.
 - Pins did not exist previously. During interlocks testing, a jumper was used.
 HV works properly.

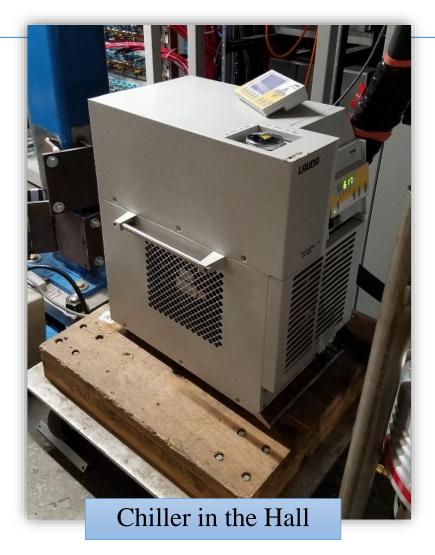
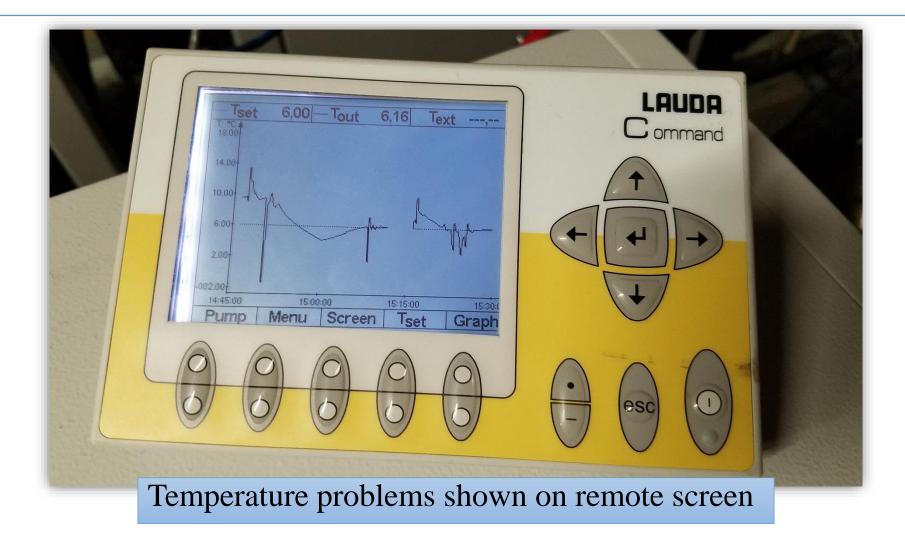
- Chiller has been having problems when Analog Input 1 from analog card is enabled.
 - Analog Input 1 allows for hardware interlocks to turn on and off pump.
 - When Input 1 is enabled, temperature of chiller will either rise rapidly or fall rapidly.

- Chiller or analog card wiring was damaged during transportation.
- Firmware could have stopped behaving properly.
- Chiller should be replaced.

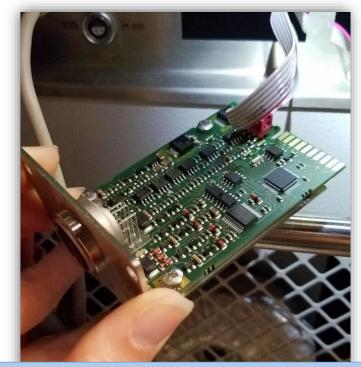
- Power-cycled chiller.
- Used DMM to check signal input from cRIO.
 - Measures either 0mA or 20mA, as expected.
- Changed "Maximum value" percentage using remote screen.
 - Analog output 1 relays pump status information to cRIO only if max value is set to 60% or lower.
 - Analog input 1 "rapid heat" or "rapid cool" depends on percentage value.

Analog card used for connection between hardware interlocks and chiller
