# **Hall B Solenoid fast Discharge on Saturday Sept 29, 2018**

**P Ghoshal  
With  
Magnet team, DSG, N Sandoval**

**Oct 3rd, 2018**

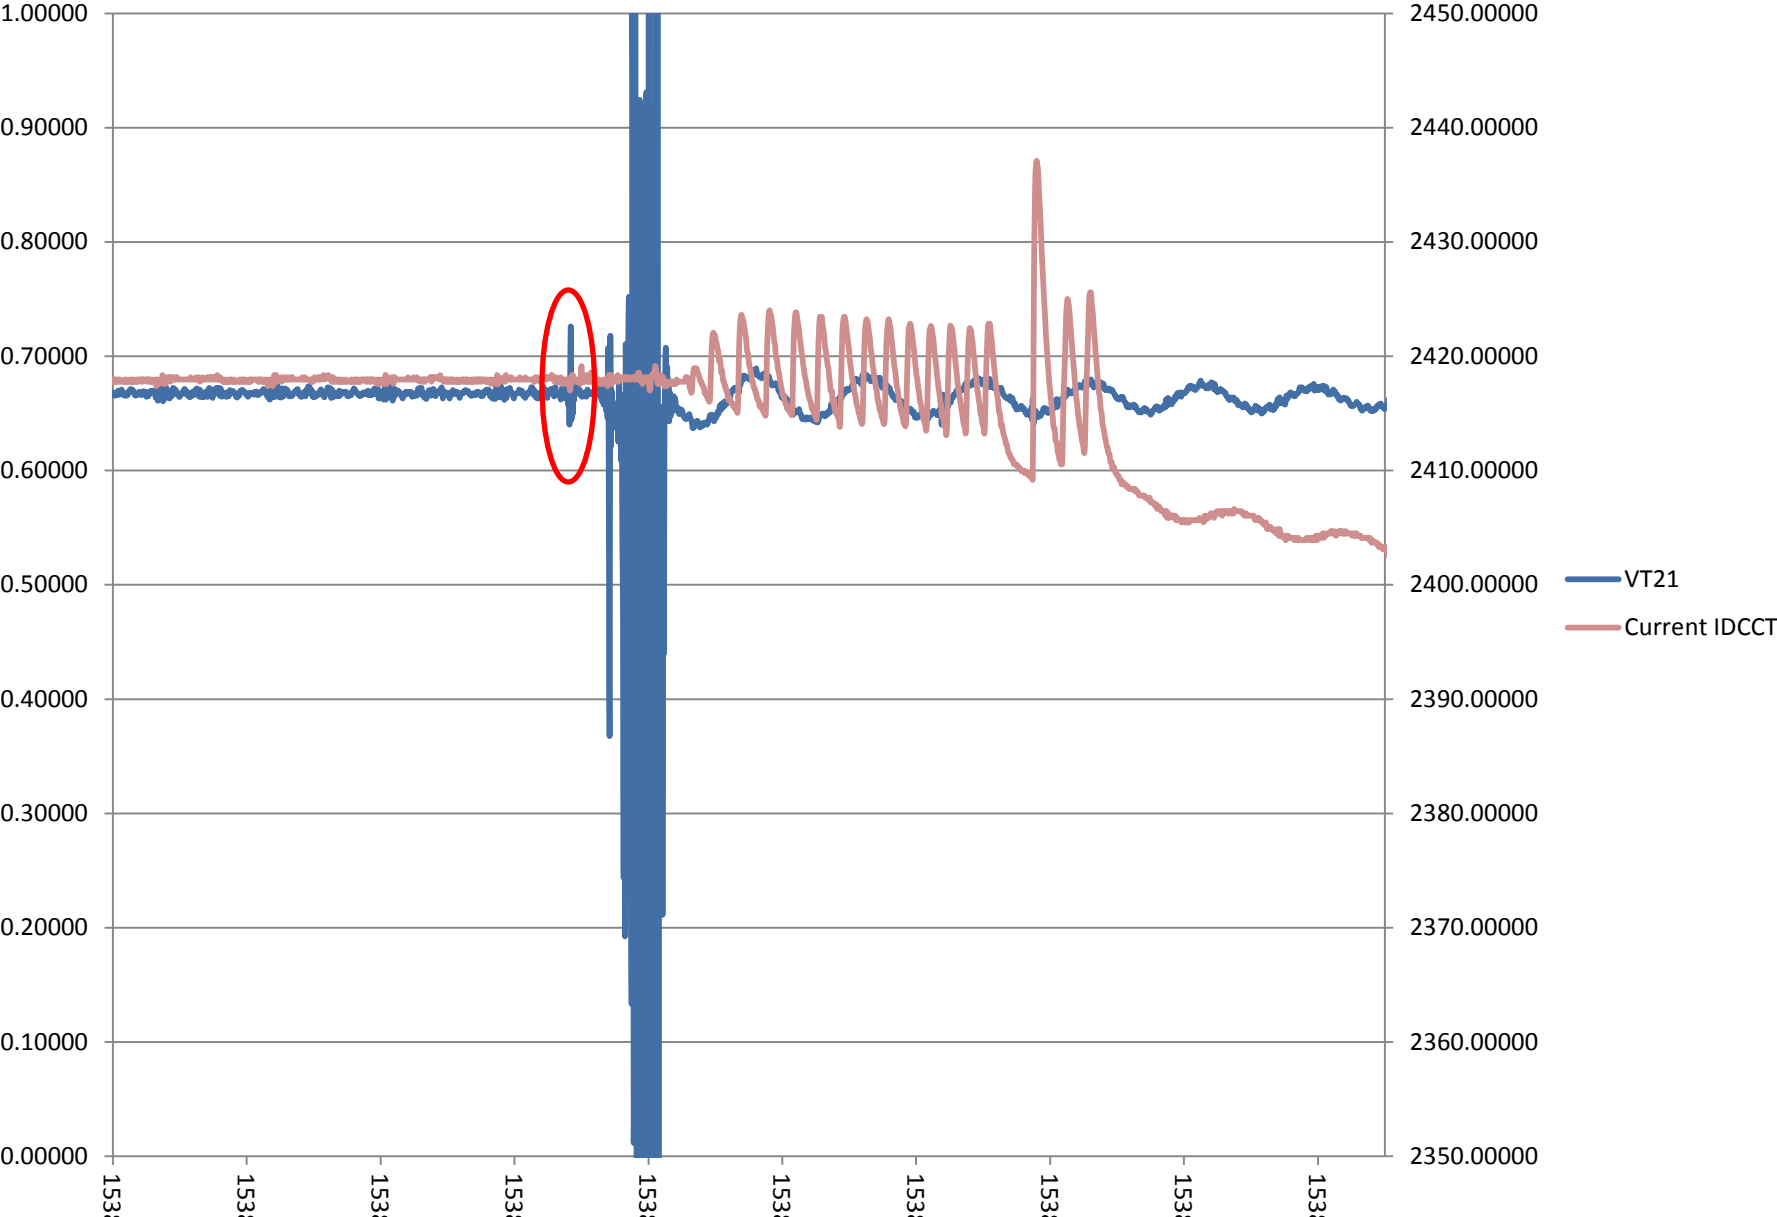
# VT21 and IDCCT

- Absolute accuracy <100 ppm (Specification)
- Line and load resolution <10 ppm (Specification)
- Measurement as seen (plots attached) – Normal operation ~331 ppm and also jumps to about 868 ppm (before tripping the magnet), based on the VT21 (voltage across the LCW bus)....

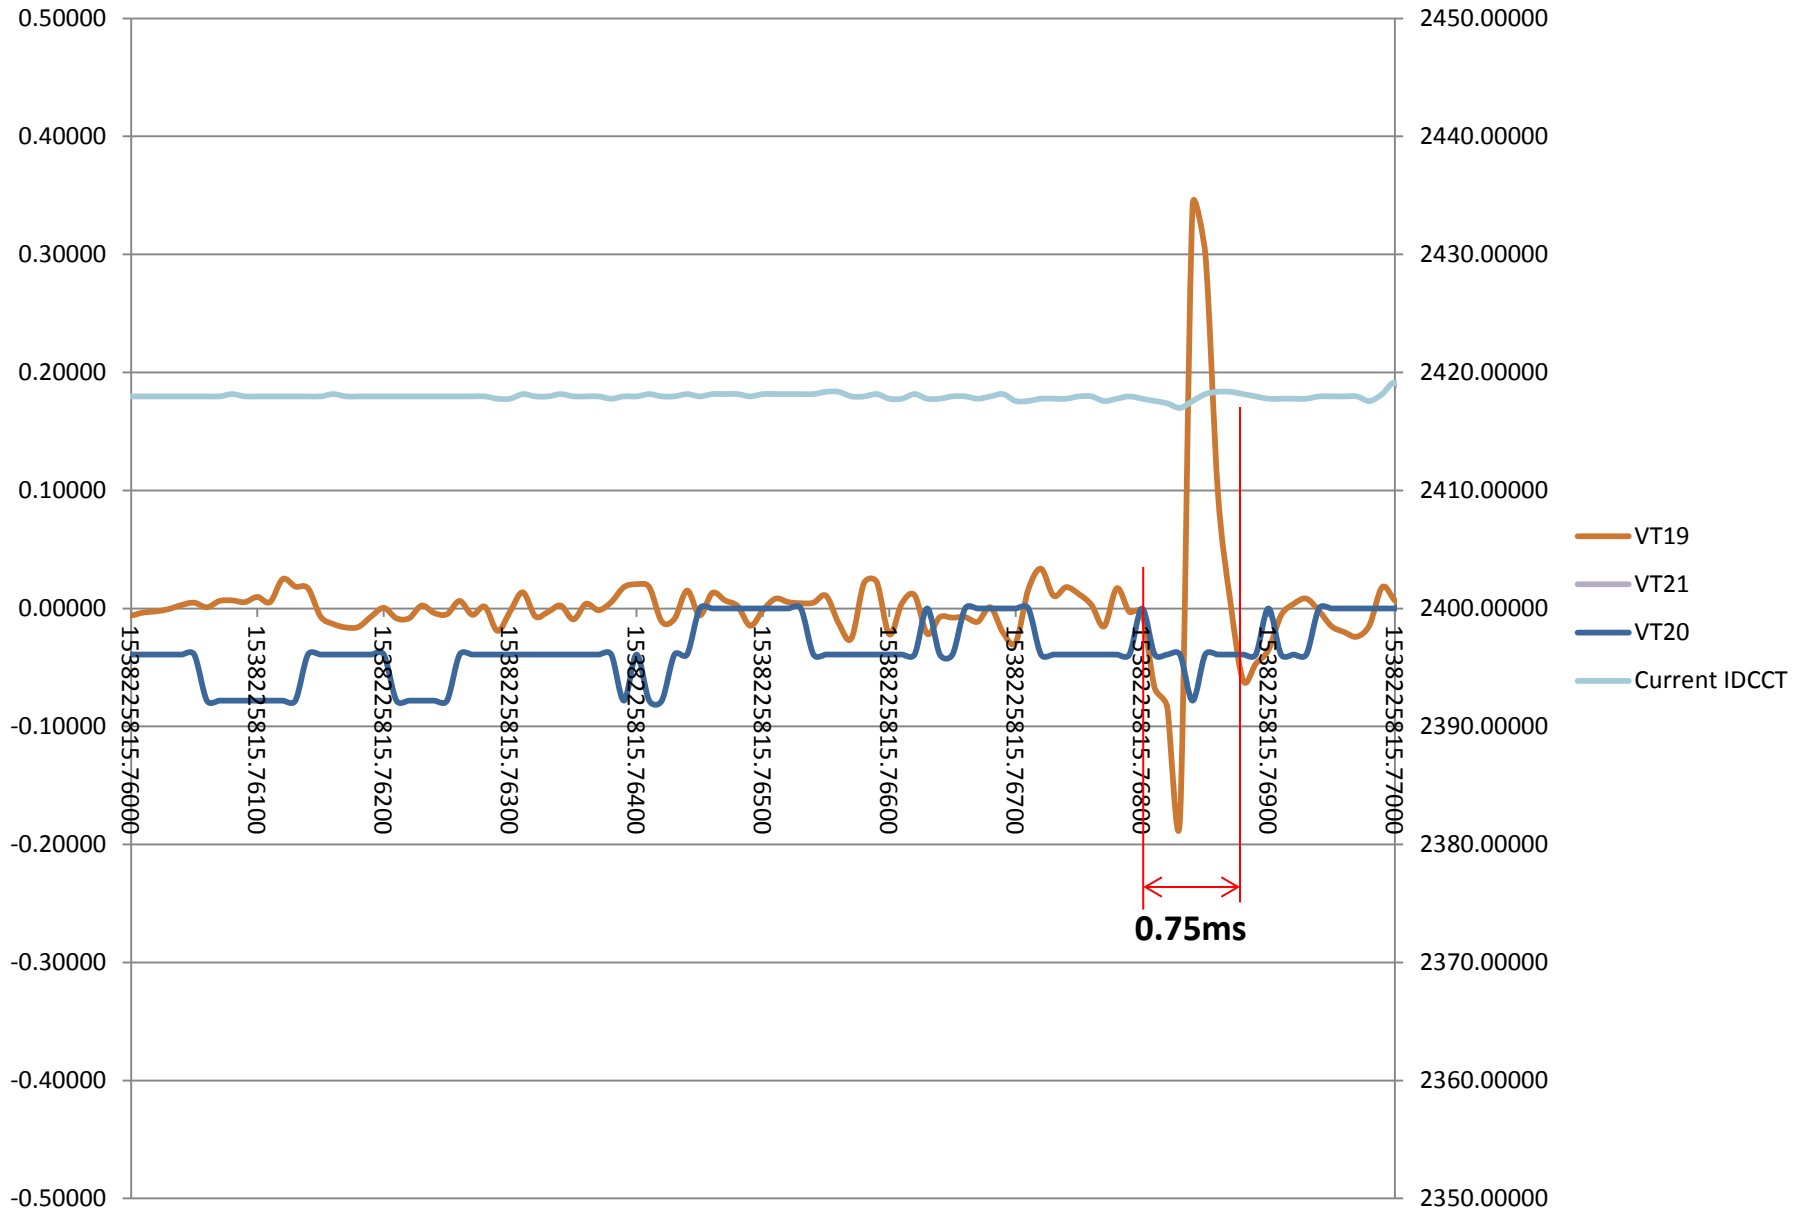
# VT19,21,20 IDCCT

- The sudden change in the voltage tap reading in the VT19 (across the VCL) is related to the movement or stick plane and sudden release...and voltage crosses the threshold (presently set at 200 mV) but recovers within 1 ms...(time lag in the QD is 999 ms) i.e., dwelling time is small...!
- This is not resistive and do not show any sign of resistance growth within the measurement time frame..! Thus the resistance is not a question... presently.
- There will be a delay in the current (MPS) because current lags the voltage due to the inductor as load (therefore, the delay in the DCCT is real)
- We presently do not have any voltage measurement across the transistor bank MPS...

- Investigate a bit further, out of the normal thinking process...MPS and its associated electronics.
- The voltage set for 2500 A is about ~6.6 V (based on 10.57 V at 4000 A). Needed to check the variation of the supply voltage across the transistor bank (driver of the supply current) and any fluctuations across the same...
