Fatal accident on the G2 construction site

Date	: 4 December 2013	Product	: -
Entity	: RC/RPO	Equipment	: power wire brush
Country	: South Korea	Ongoing operation	: eliminating rust of piping
Site	: Daesan	Main type of cause	: strangulation
Unit	: Construction site: G2 PJT (CFU)	Main type of consequence	: fatality
<input checked="" type="checkbox"/> TOTAL	<input type="checkbox"/> External company	Typology of event	: physical injuries : others
<input checked="" type="checkbox"/> Personal safety <input type="checkbox"/> Process Safety <input type="checkbox"/> Product non-conformity <input type="checkbox"/> Transport <input type="checkbox"/> Industrial hygiene <input type="checkbox"/> Environment <input type="checkbox"/> Security

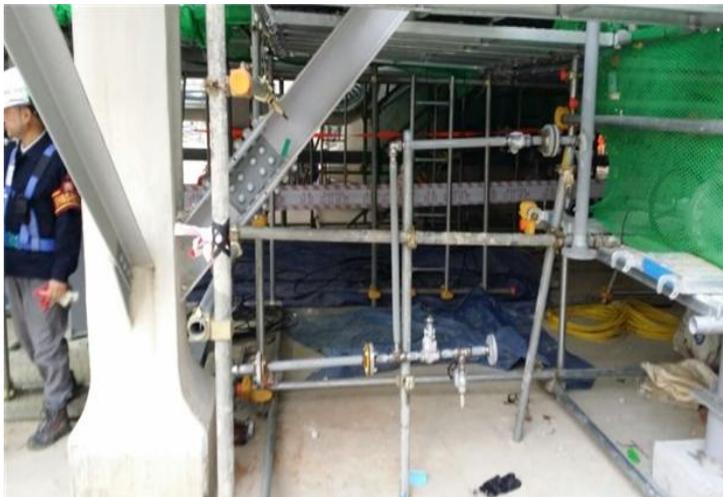
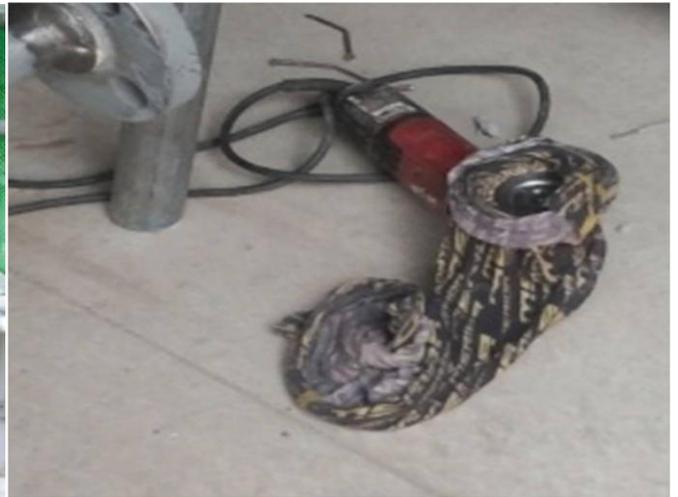
- The contractor worker was working to eliminate the rust on 1 inch piping with a power wire brush before painting.
- The victim was wearing a neck muff to keep warm from cold weather.
- The neck muff rolled into the power wire brush and the victim was suffocated by being strangled his respiratory tract by the muff around the neck.

Immediate causes	strangulation : a neck muff around the worker's neck rolled into the power wire brush and pressed the victim's respiratory track
Probable root causes	under investigation

Loose clothing and open (= unprotected) rotating equipment are not compatible !

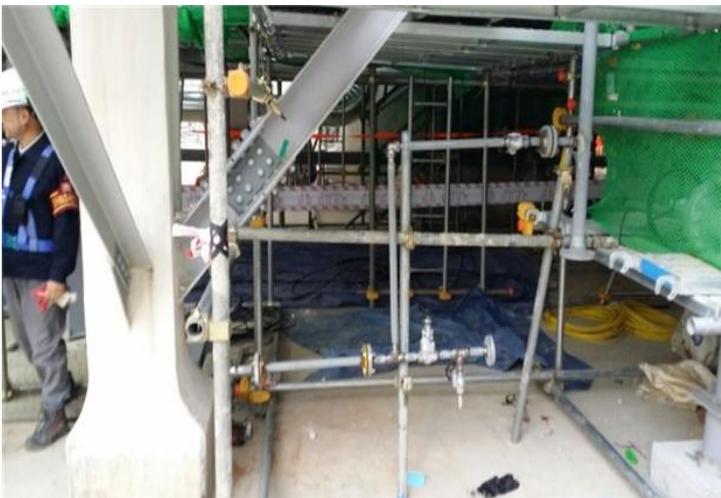
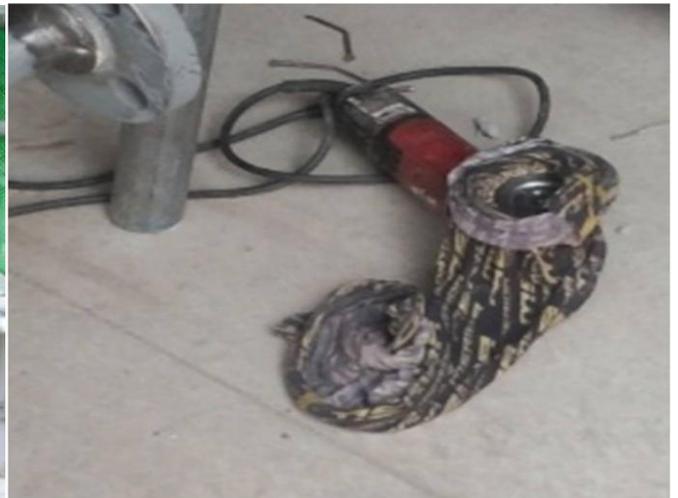
- Un sous-traitant était en train d'enlever la rouille d'une tuyauterie d'un pouce avec une brosse électrique avant d'entamer des travaux de peinture.
- La victime portait une écharpe autour du cou pour se protéger du froid.
- L'écharpe a été emportée par la brosse électrique et la victime a été étranglée par l'écharpe fortement serrée autour du cou.

Causes immédiates	étranglement : écharpe autour du cou de la personne a été emportée par la brosse électrique et a fortement serré son cou
-------------------	--

Vêtements non attachés et machines tournantes non protégées ne sont pas compatibles !
