Material Handling Events Across DOE

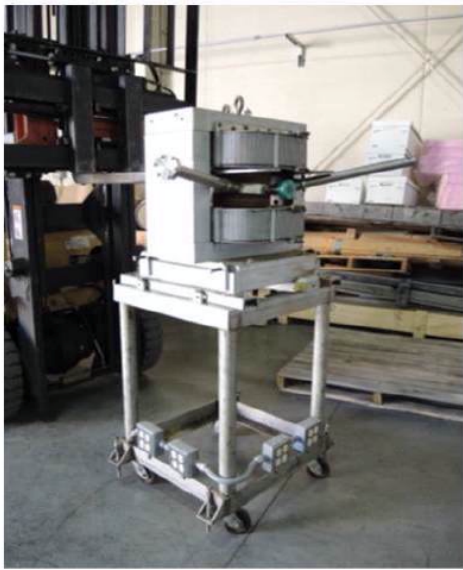
Figure 1. Scattering chamber

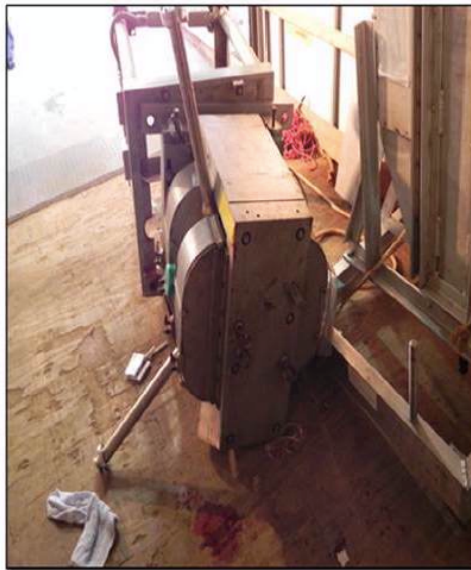
This past March, an Oak Ridge National Laboratory (ORNL) employee was severely injured when a 1,585 lb. scattering chamber on a stand with wheels overturned while it was being moved down a ramp into the bed of a box truck. The scattering chamber assembly was 65 inches tall and had a high center of gravity. The work activity was to load the scattering chamber and stand into a privately owned truck after it was sold as excess equipment at auction. Two Salvage Handlers were moving the scattering chamber – one Salvage Handler was behind the chamber as they guided it down the slightly inclined (6.25%) loading ramp and the other Salvage Handler was in the fall zone in the direction of motion. When the leading wheels reached the transition between the loading ramp and the truck bed, the scattering chamber tipped over and onto the Salvage Handler in the path of travel, pinning him underneath. Staff from within the facility responded immediately, removed the scattering chamber from the injured employee, and rendered aid. The employee sustained fractures to his lower legs, a broken right thumb, and several lacerations.

Figure 2. Overturned chamber in truck

1. The equipment was top-heavy, but that not recognized by the workers, although it was identified on the transfer paperwork.
2. The equipment was on wheels, so the workers assumed that it was safe to roll the equipment. Therefore they chose not to use a forklift to move the equipment.
3. There had been a recent reorganization and a number of the workers and supervision were inexperienced. One worker was “matrixed” to the organization for the day. Supervision was not actively engaged.
4. There were time pressures to quickly move the equipment for the customers.
5. One of the workers had been involved in an earlier mishap with this equipment tipping, but did not share that information.

In these 3 cases, there was a failure to recognize the inherent instability of the load. This allowed a worker to place himself between the load and an obstruction – the proverbial “rock and a hard place”. All 3 cases demonstrate the need to consider “what if” in work planning – What if this equipment is top heavy? What if the load tips? What if the load shifts during transport?
