Solenoid Status Report

Pablo Campero 8/2/17

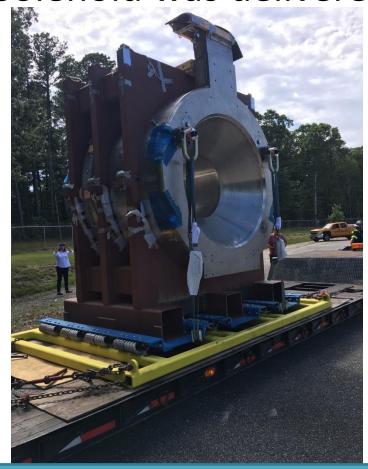
Solenoid was delivered at JLab on June 28th

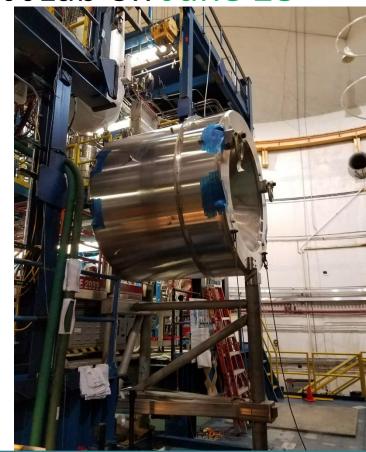
Solenoid placed on hall B outside on June 27th

Downstream view of Solenoid magnet on its assembly car support at hall B

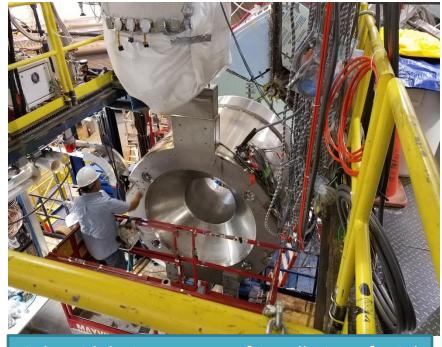
Solenoid during process of installation of axial supports

- Initial alignment align to the beamline
 - Re-tension radial suspension links
 - Removed shipping restrains and installed
 Z-axis restrains
 - Completed on 06/29

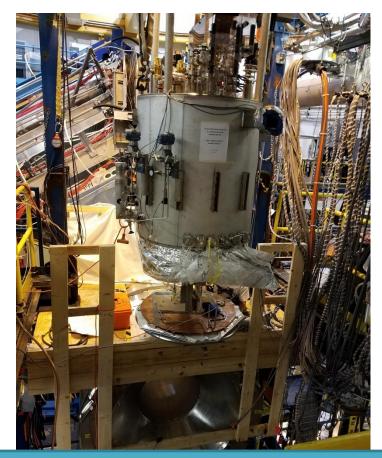
Solenoid Service Tower without bottom shield during alignment with Solenoid

- First alignment of the SST at the top of the Solenoid
- Splice block components installed - Completed on July 8th.
- Installation of voltage taps and wiring –Completed on July 17th.
- Pressure leak test of the Solenoid Magnet shield piping at 320 psig completed on July 12th.

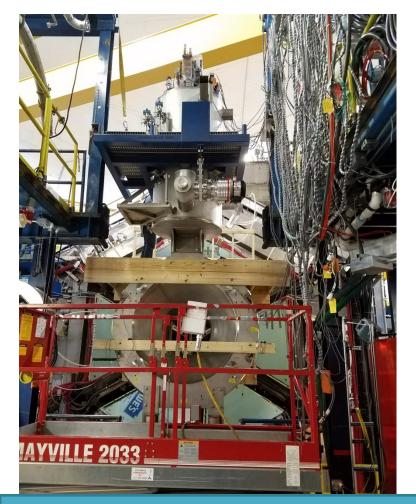
Solenoid final assembled with SST and Vacuum system

- Completed primary vacuum instrumentation installation on Jul 26th.
- All planned welding on parts of the Solenoid Installation was completed on Jul 31st.
