# HDice Rack #1 Grounding

# Rack #1

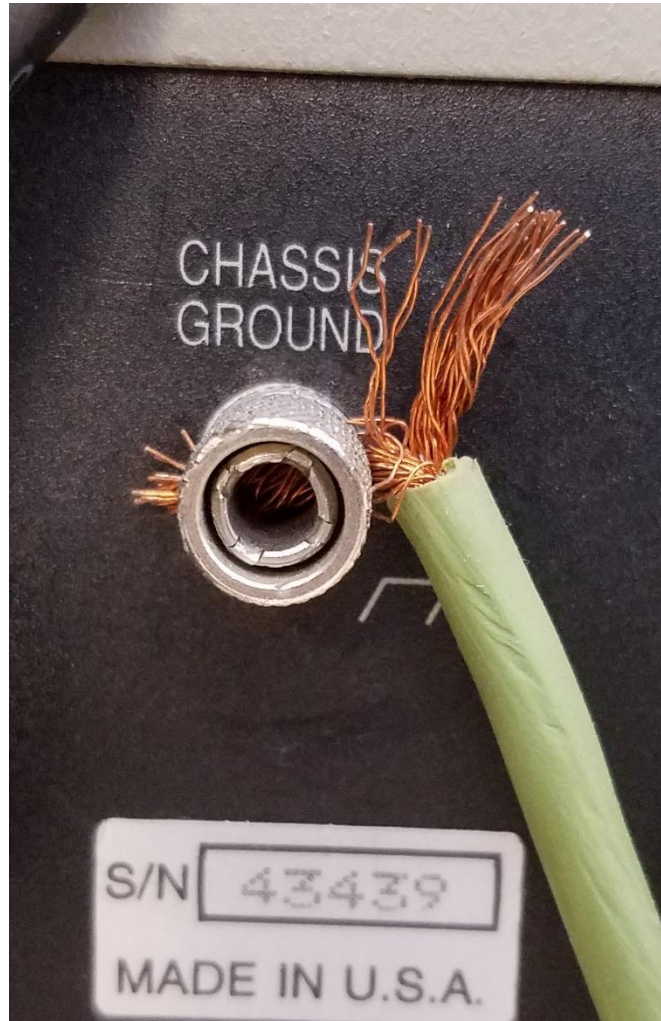
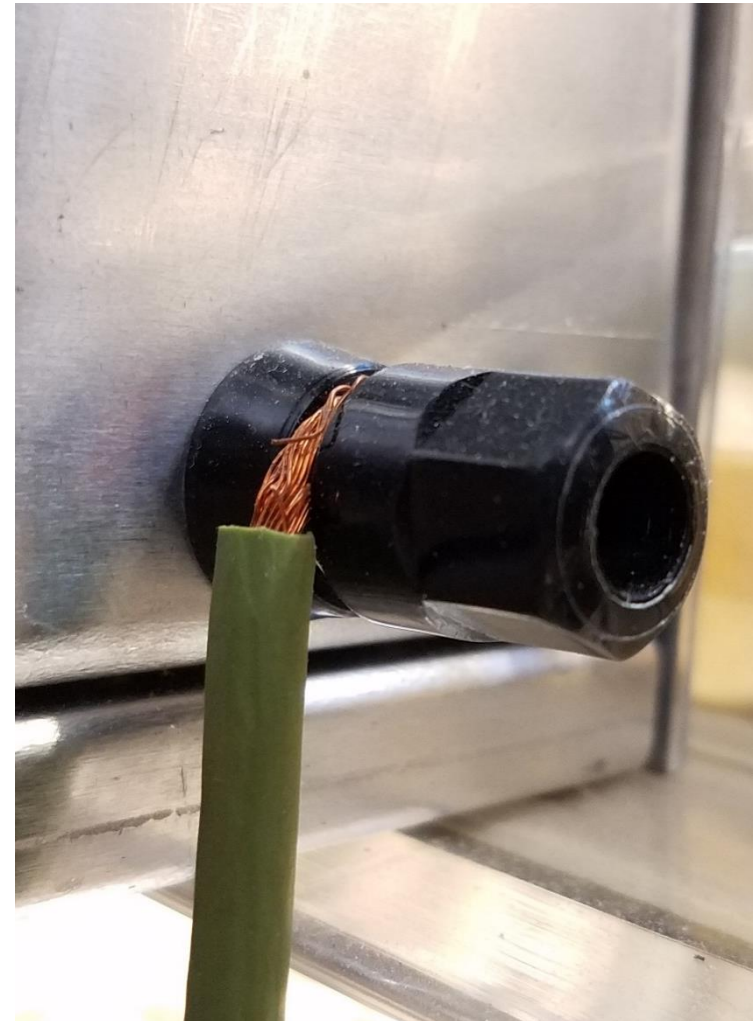
# Grounding: Before

- Grounding on Lock-in Amp and RF Box before fixing cables.

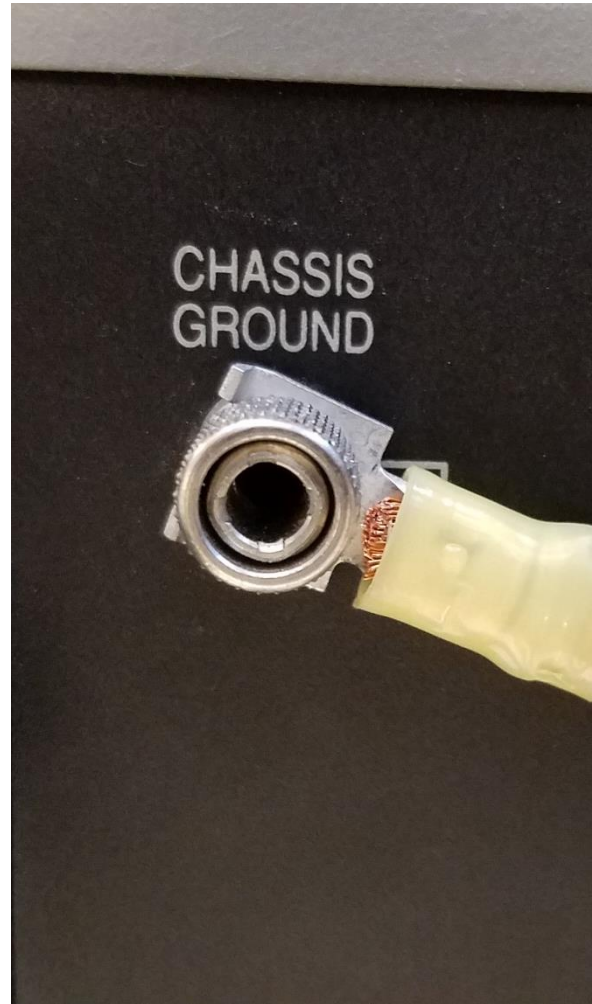
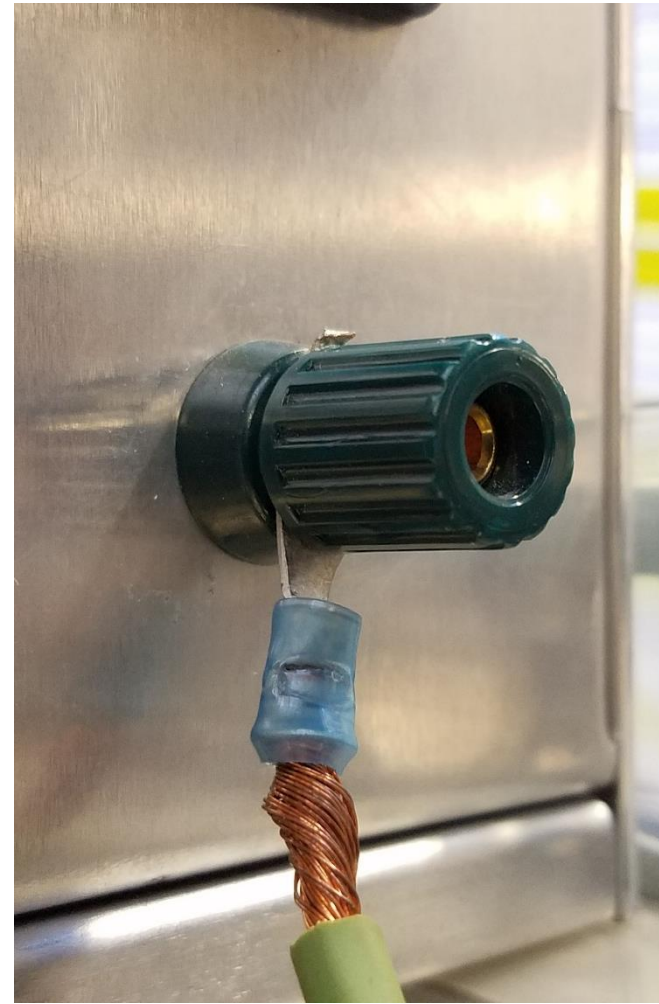
# Grounding: After

- Grounding on Lock-in Amp and RF Box after fixing cables.

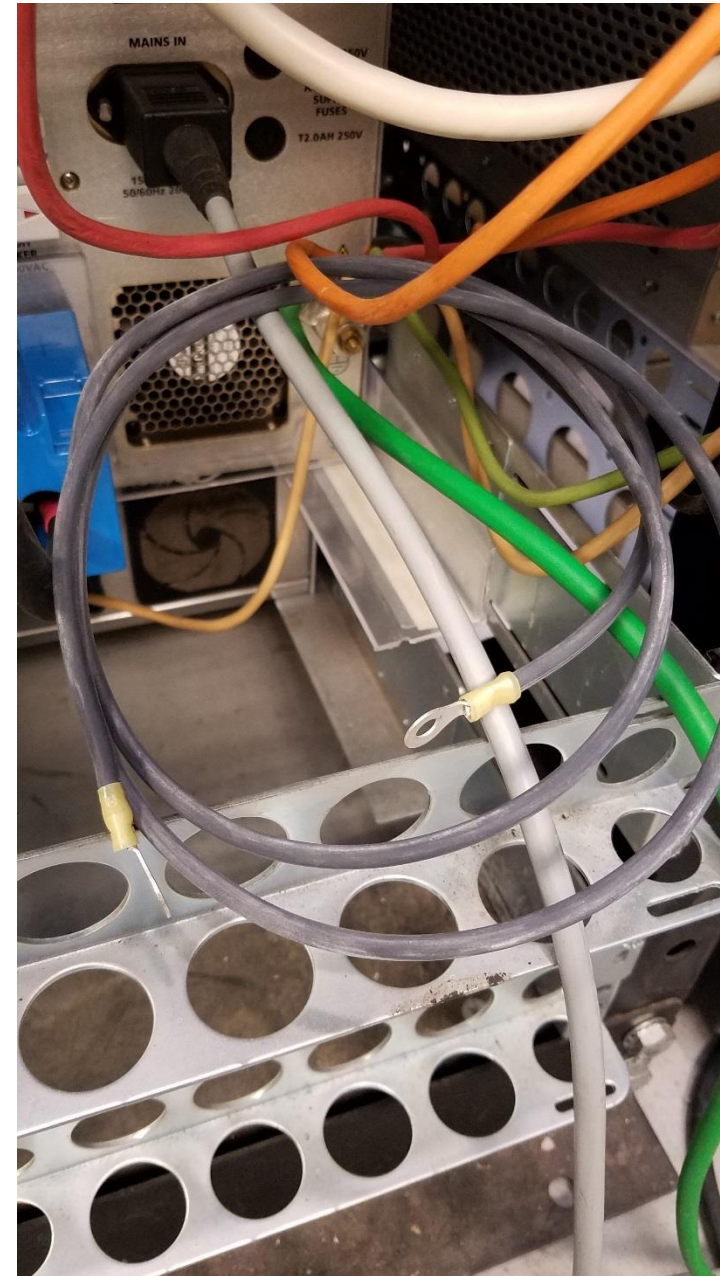
# Extra Cable

- Additional cable was fabricated to connect Rack #1 to Rack #2.
  - Cable requested to be detached from racks until needed.
