Web Date: April 19, 2016

Spark from pressure gauge caused University of Hawaii explosion, fire department says

Postdoc Thea Ekins-Coward, who lost an arm in the incident, was using a gauge r specified for work with flammable gases

By Jyllian Kemsley

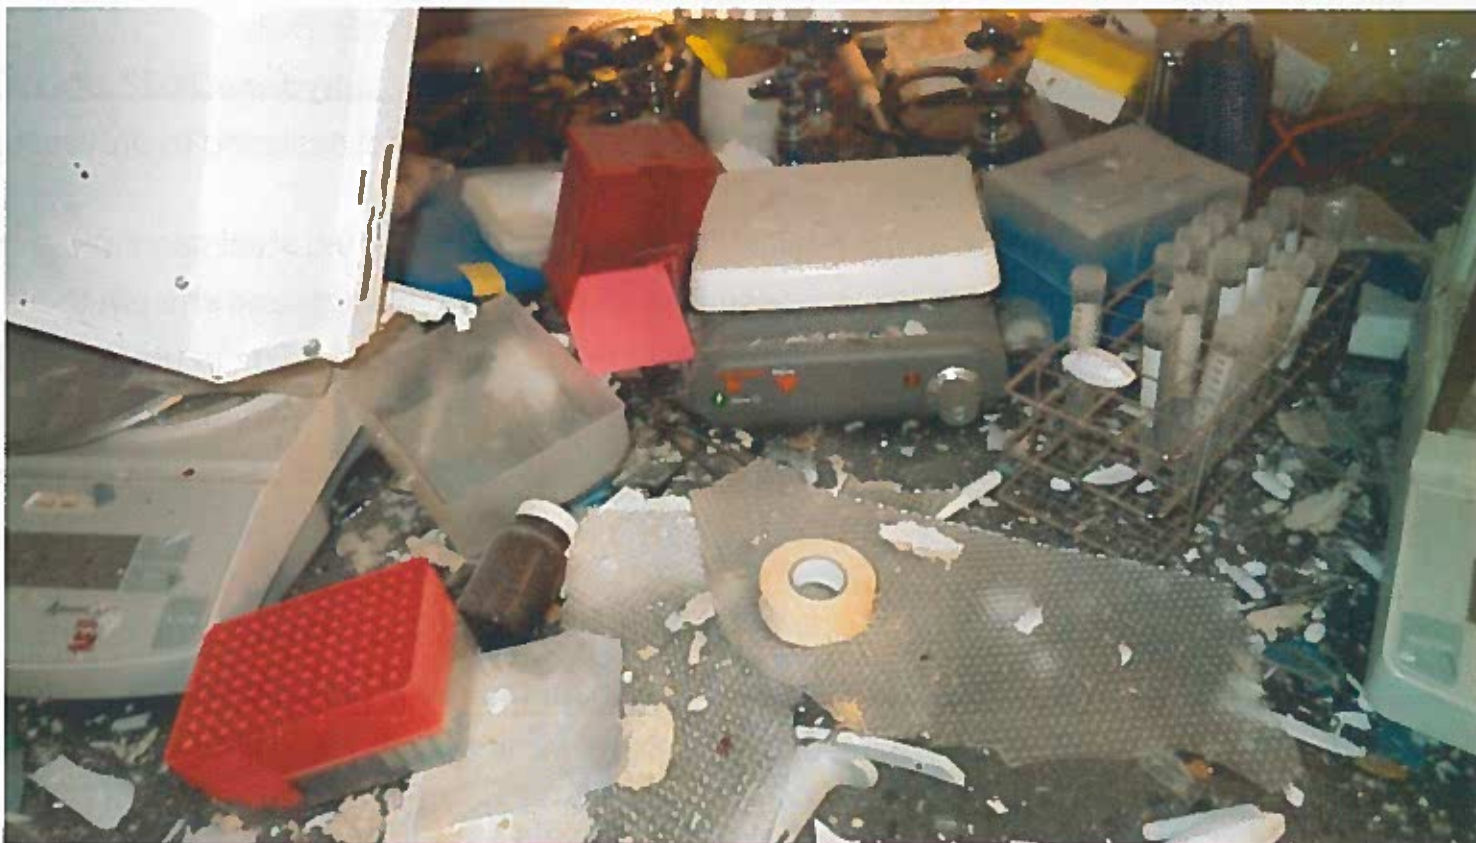
Debris littered a lab bench after the explosion.

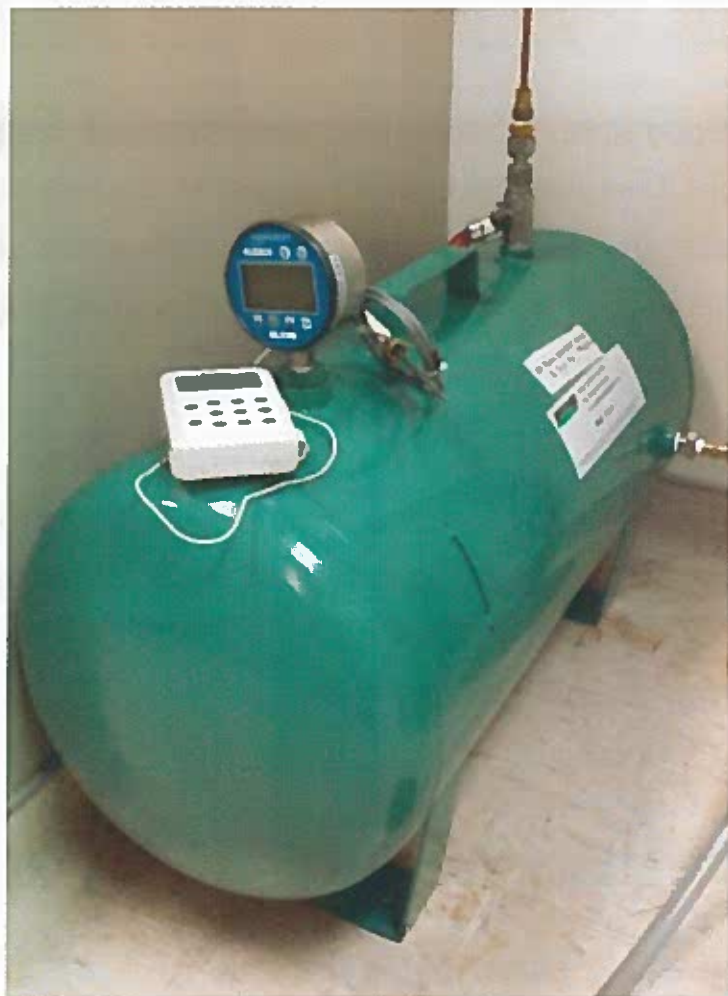
The steel tank that ruptured in the March 16 explosion.
Credit: Jian Yu/U Hawaii

But after Ekins-Coward started in the lab last fall, she purchased a 49-L steel gas tank, a different gauge not rated as intrinsically safe, a pressure-relief valve, and fittings, and she put them together, Yu and Ekins-Coward told fire department investigators, according to the report. Ekins-Coward would add the gases to the portable tank, which would then be connected to the bioreactor. She was using a mixture of 70% hydrogen, 25% oxygen, and 5% carbon dioxide for her experiments, the report says.

On the day of the incident, the 49-L tank exploded when Ekins-Coward pressed the off button the gauge. "She did not lose consciousness or hit her head; she was aware that she lost her arm in the explosion," the report says. "She couldn't open the door to the lab, the door was stuck closed." Security officers and a graduate student kicked in the door to help Ekins-Coward get out. Her right arm was severed just above the elbow, the report says.

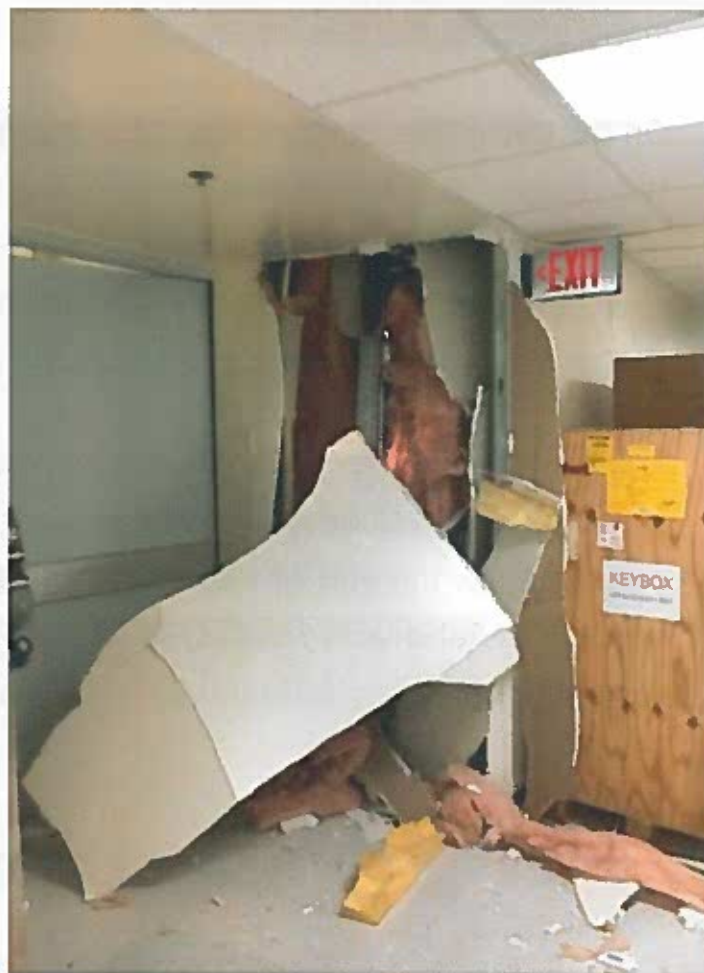
The explosion caused damage in the hallway outside of the lab.
Credit: Honolulu Fire Department

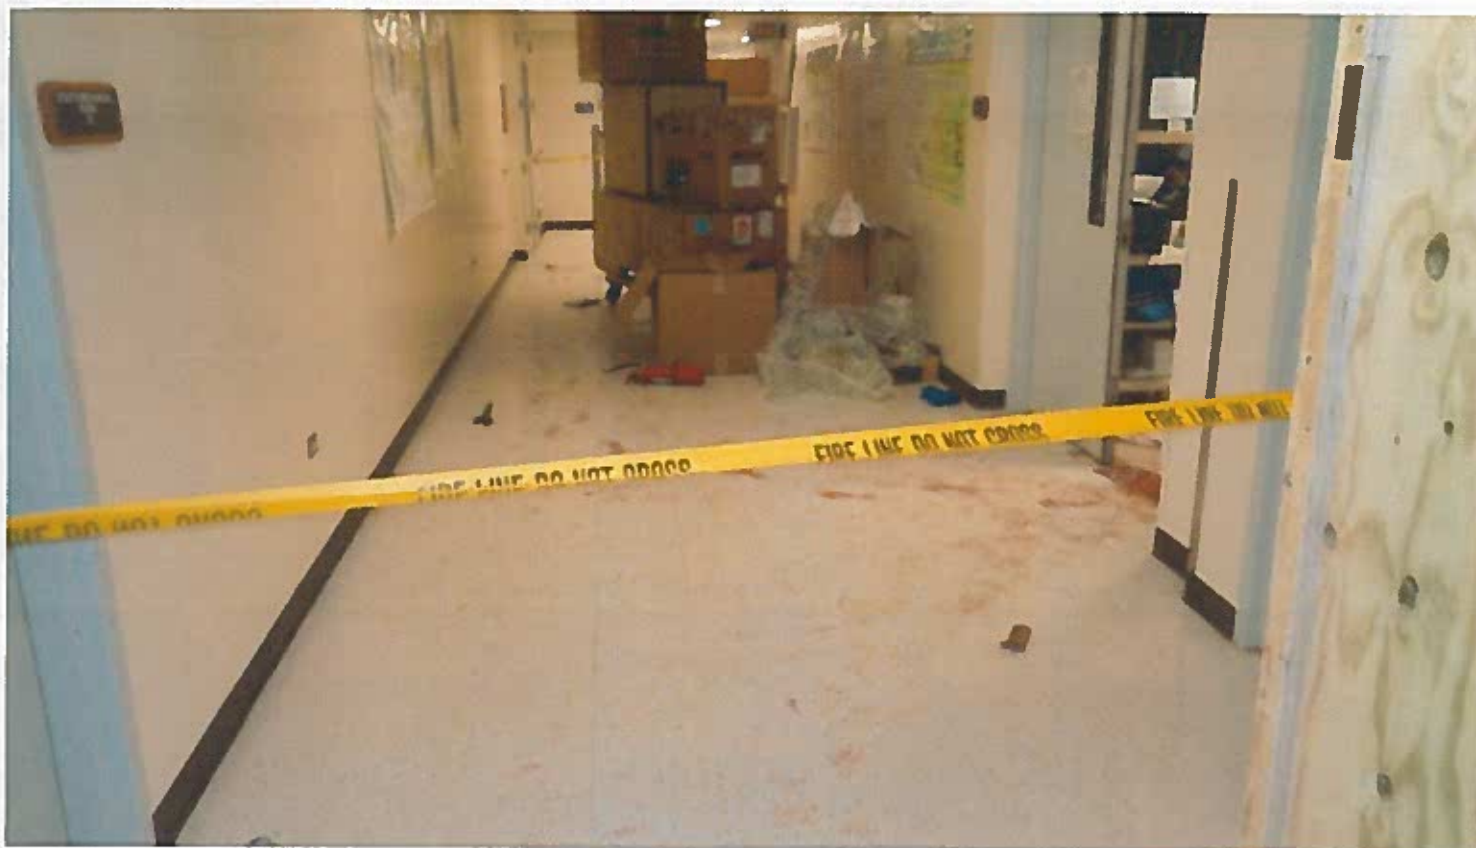
The hallway outside the lab door after the explosion.

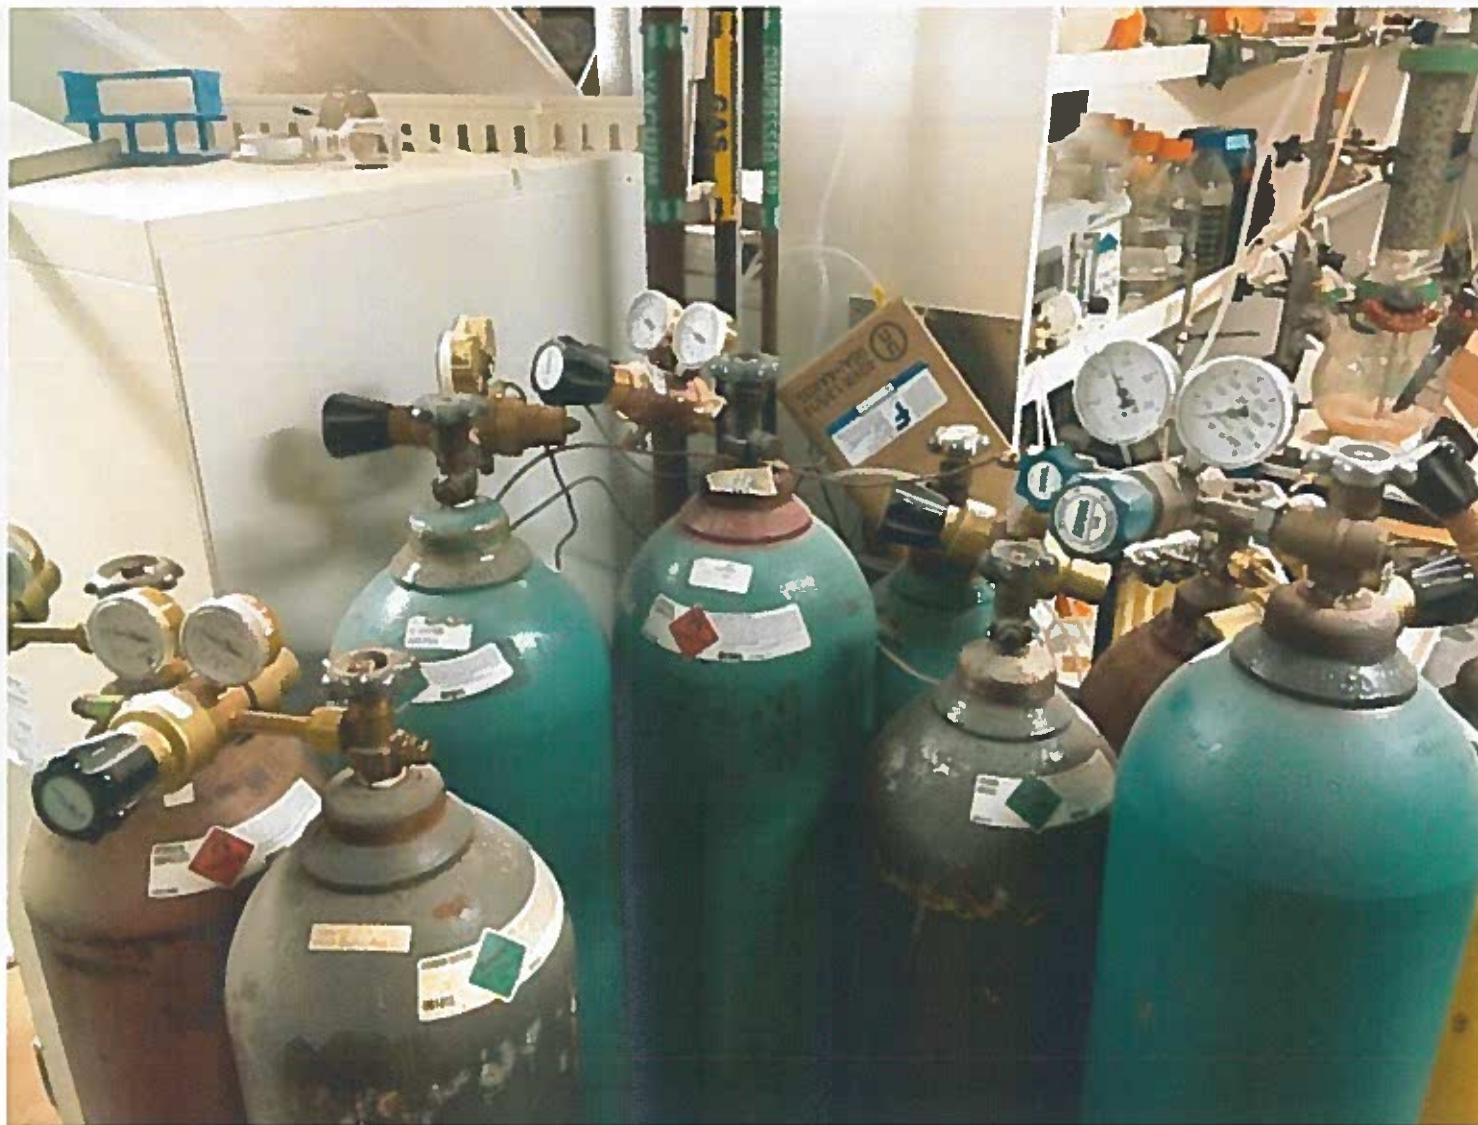
Compressed gases in the lab included hydrogen, carbon dioxide, helium, and carbon monoxide.

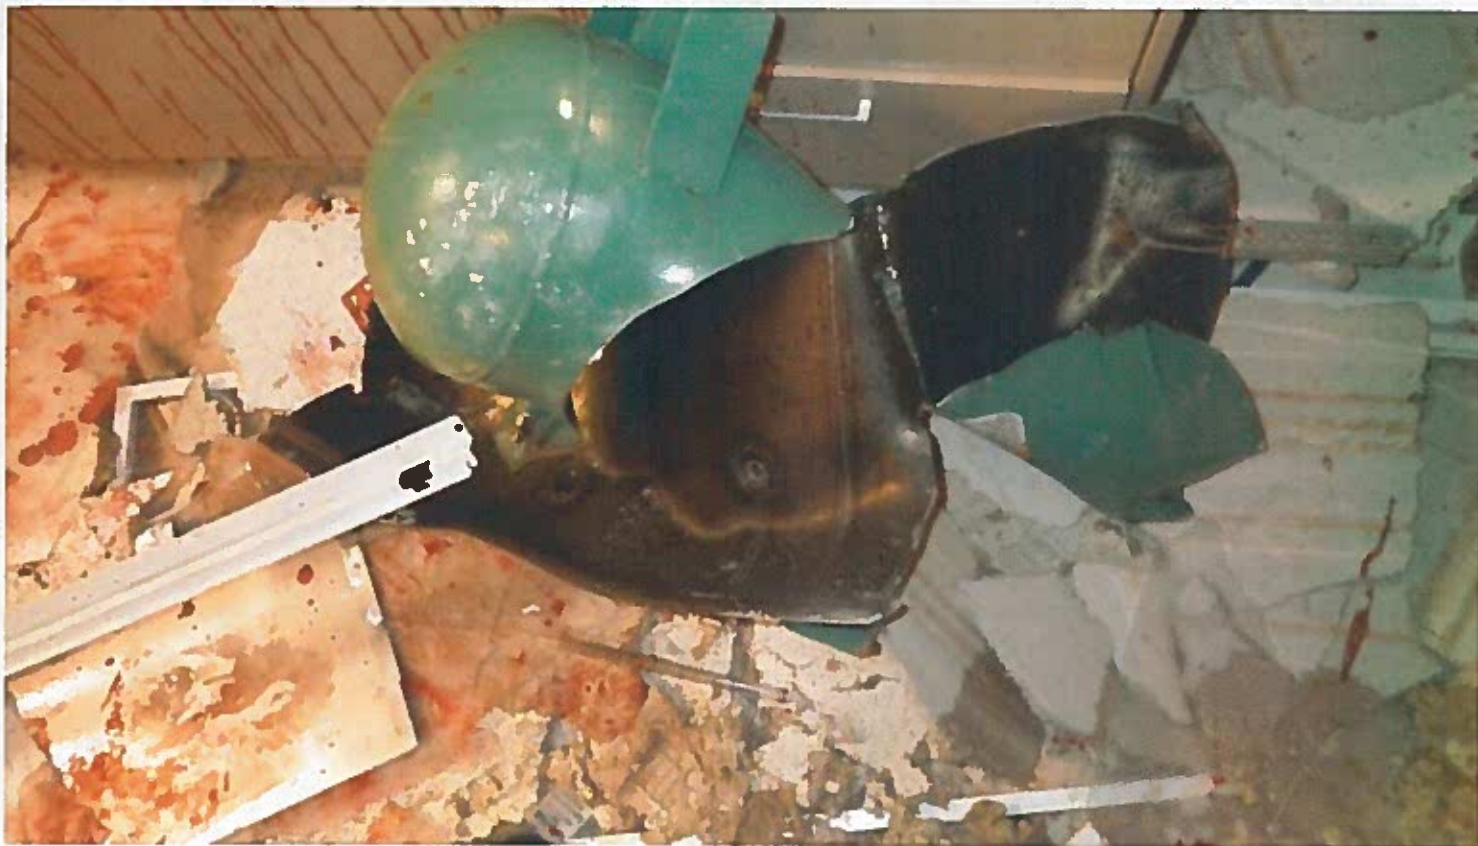
This steel tank ruptured during the explosion, which severed a researcher's arm.

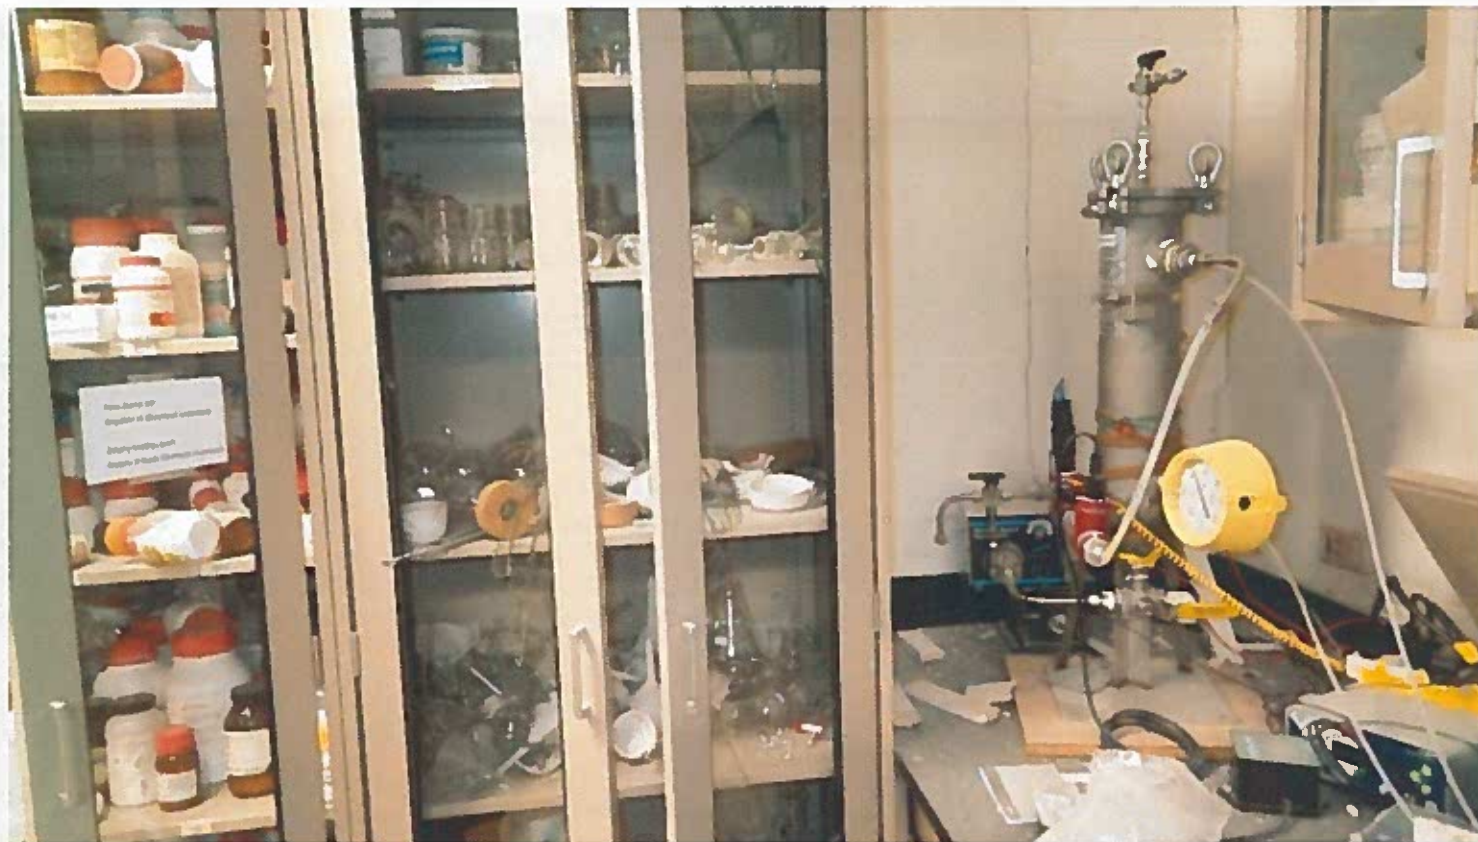
Chemical bottles fell and glass broke in the northeast corner of the lab, next to the bioreactor for growing bacteria.

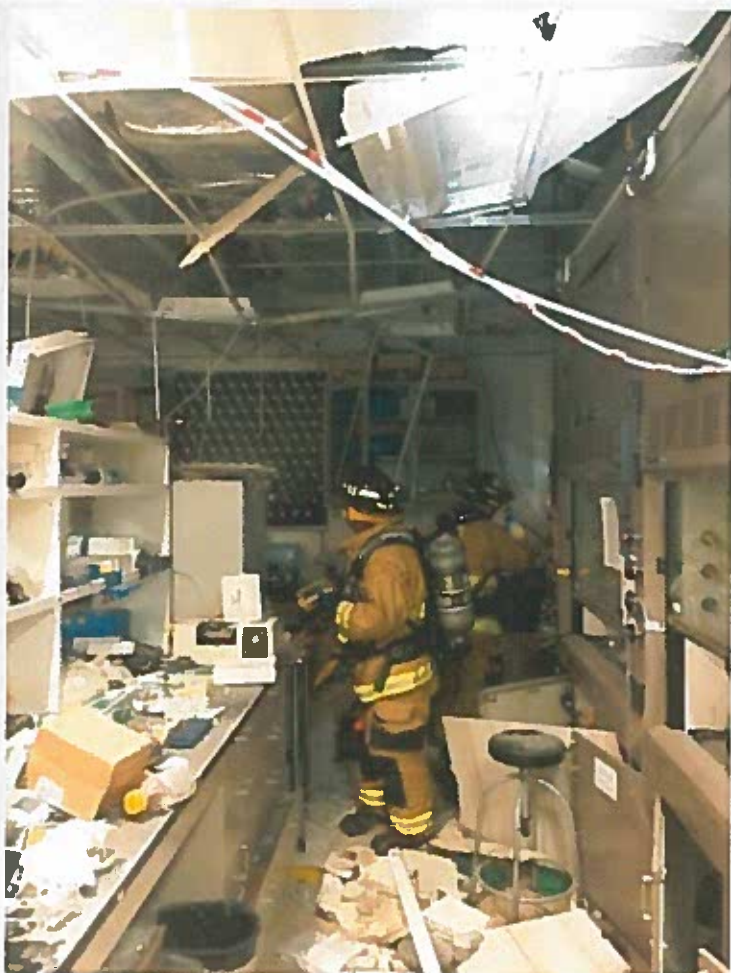
The explosion knocked down ceiling panels, broke light fixtures, and scattered debris throughout the lab.

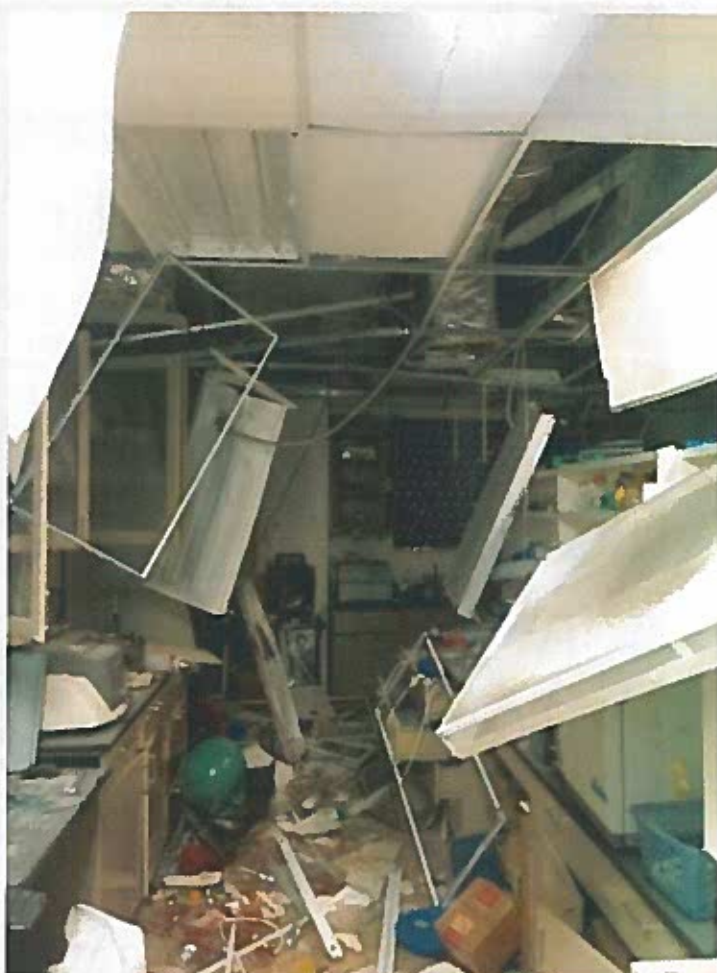
The remains of the steel tank sit at the site of the explosion, near the south wall of the lab.

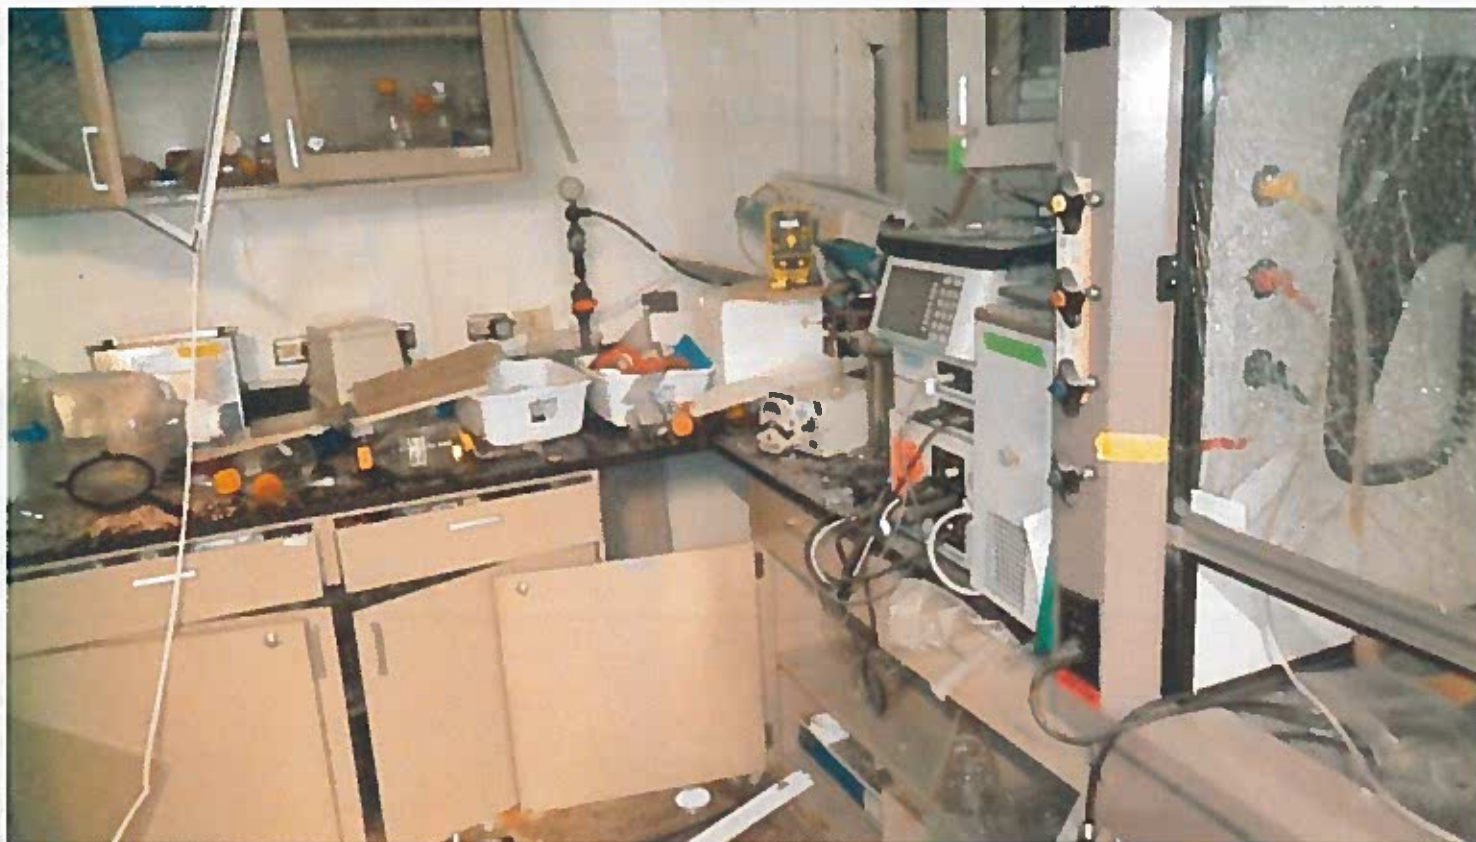
The explosion also shattered fume hood sash windows and knocked over equipment in the northwest corner of the lab.

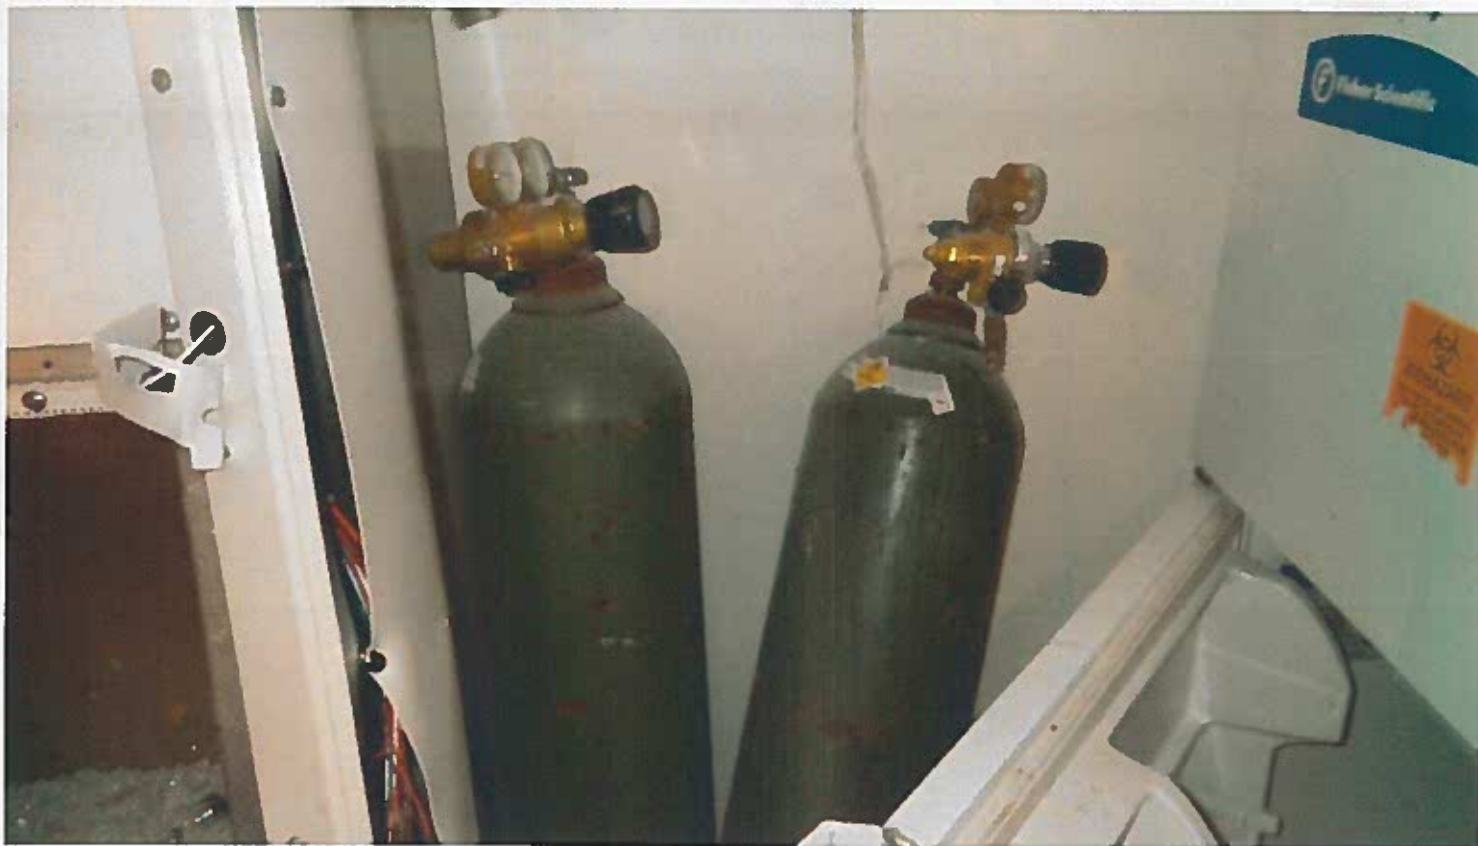
An oxygen cylinder was nearly knocked over in the southwest corner of the lab, something that could have added to the damage.

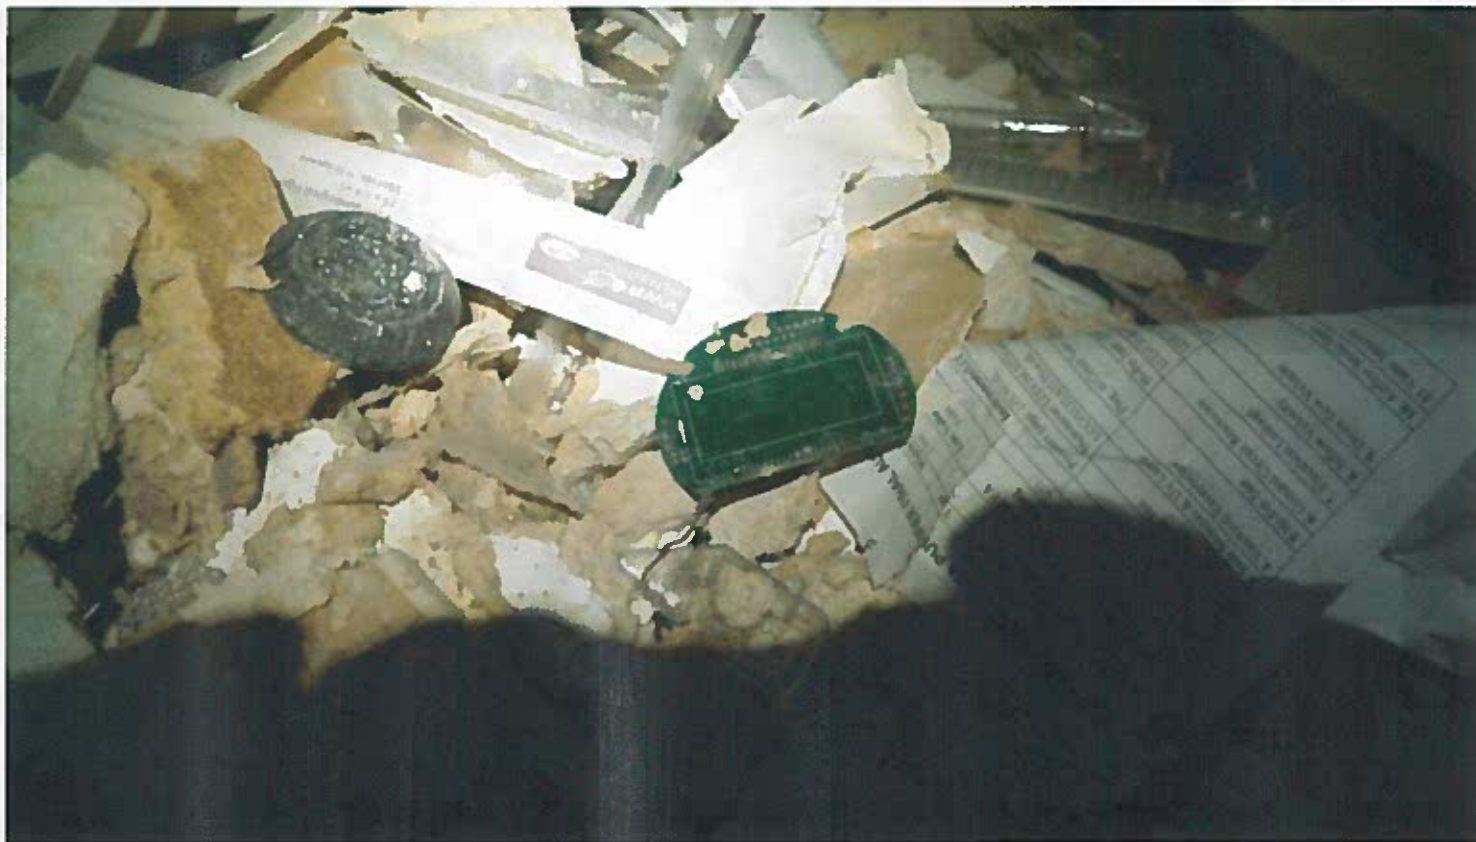
Possible circuit board from the pressure gauge that caused the explosion.

An explosion last month that caused a University of Hawaii, Manoa, postdoctoral researcher to **lose an arm** <<http://cen.acs.org/articles/94/i13/Researcher-Thea-Ekins-Coward-loses.html>> was caused by a spark from a digital pressure gauge that was not designed for use with flammable gases, says a **Honolulu Fire Department investigation report** <<https://www.documentcloud.org/documents/2805224-2016-05-30-Honolulu-Fire-Department-Report-on.html>> .

The gas gauge identified in the paper is an “intrinsically safe” model designed to prevent ignition.

In the week before the incident, a similar set-up with a 3.8-L tank resulted in a “small internal explosion” when Ekins-Coward pressed the off button on the gauge, the fire department report says. She also occasionally experienced static shocks when touching the tank, which was not grounded. She reported the shocks and possibly the small explosion to Yu, who told her not to

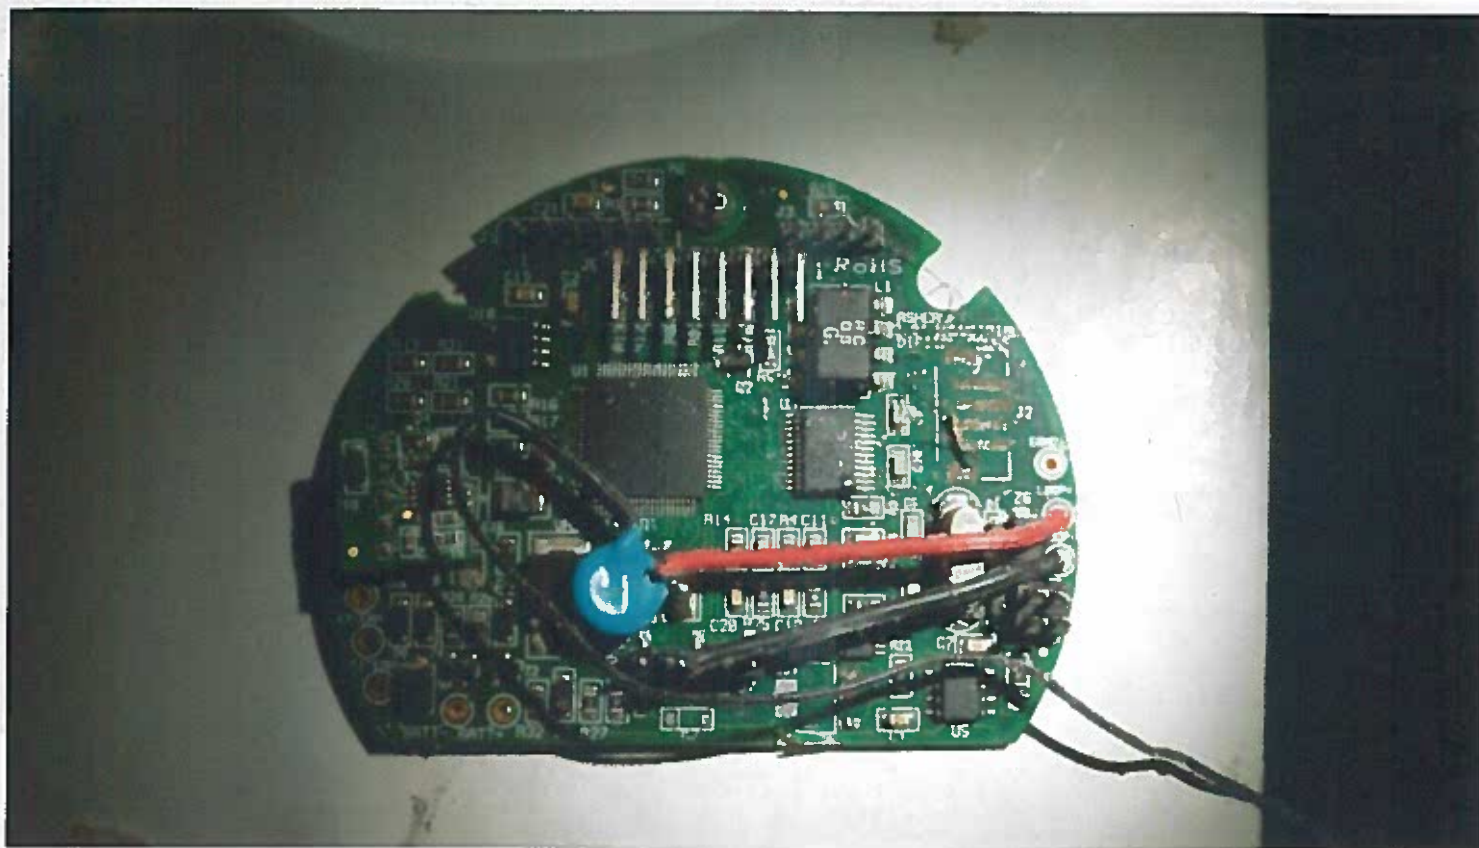
Photo of a circuit board on top of debris.
