C75 Pair 4 Flange Photos (Pair leaking)

29Sep2020

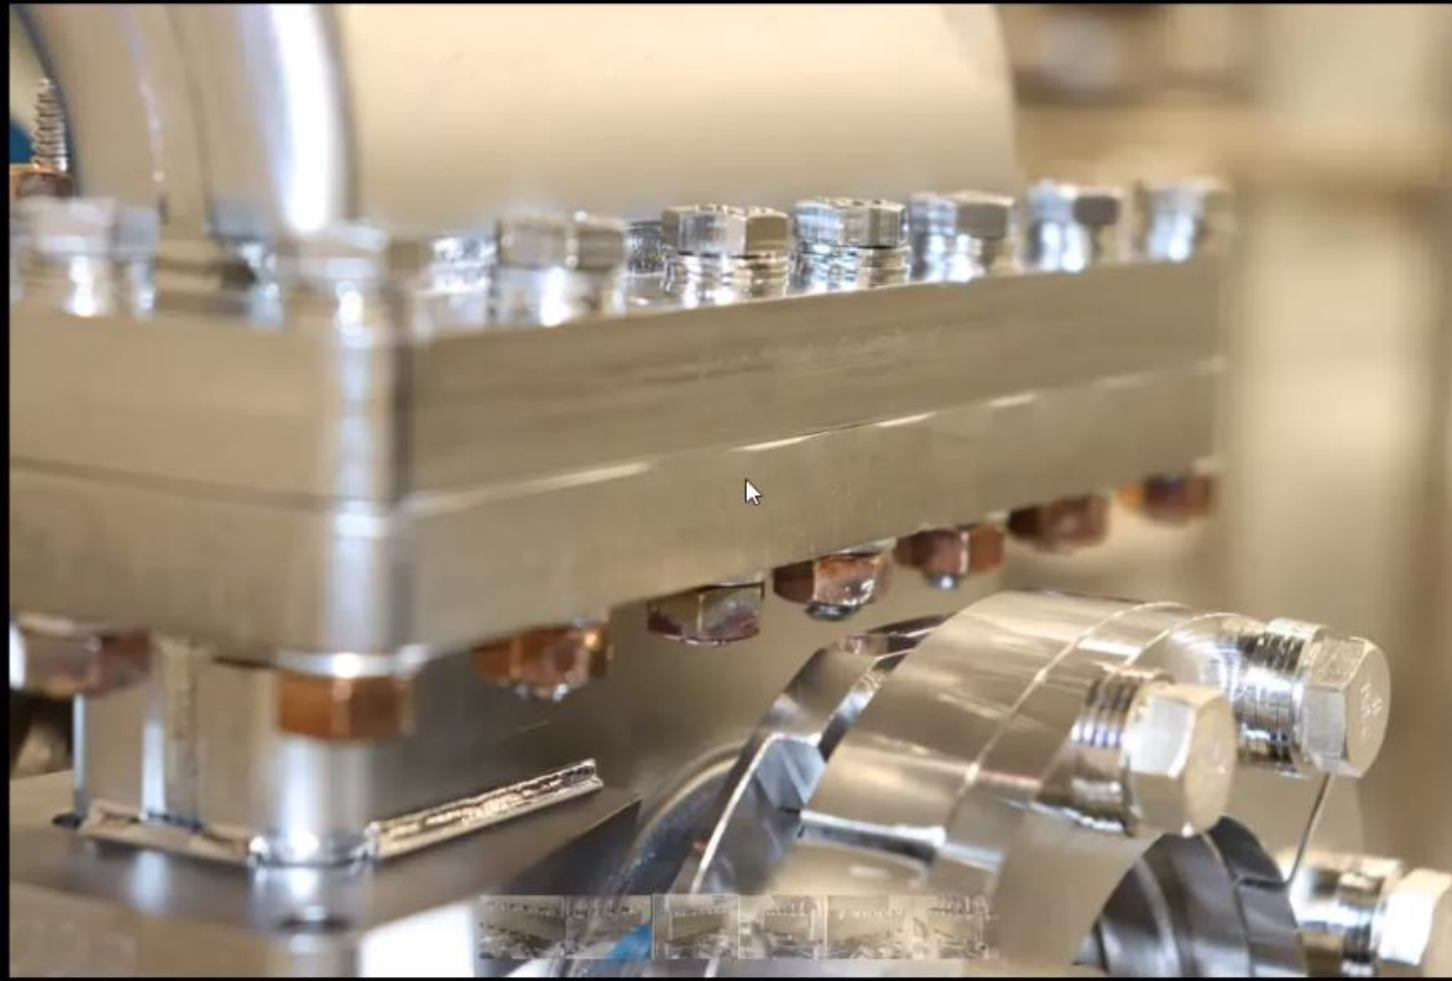
Good morning as discussed I torqued bolts and studs to 120 inch pounds this morning and re-leak checked we had no change in leak rate since 6/27 after re-torque I notice and felt what appears to be the flange bulging out in line with the bolts and studs I have included pics to show what I mean along with from the other dogleg flange that isn't leaking to compare to.

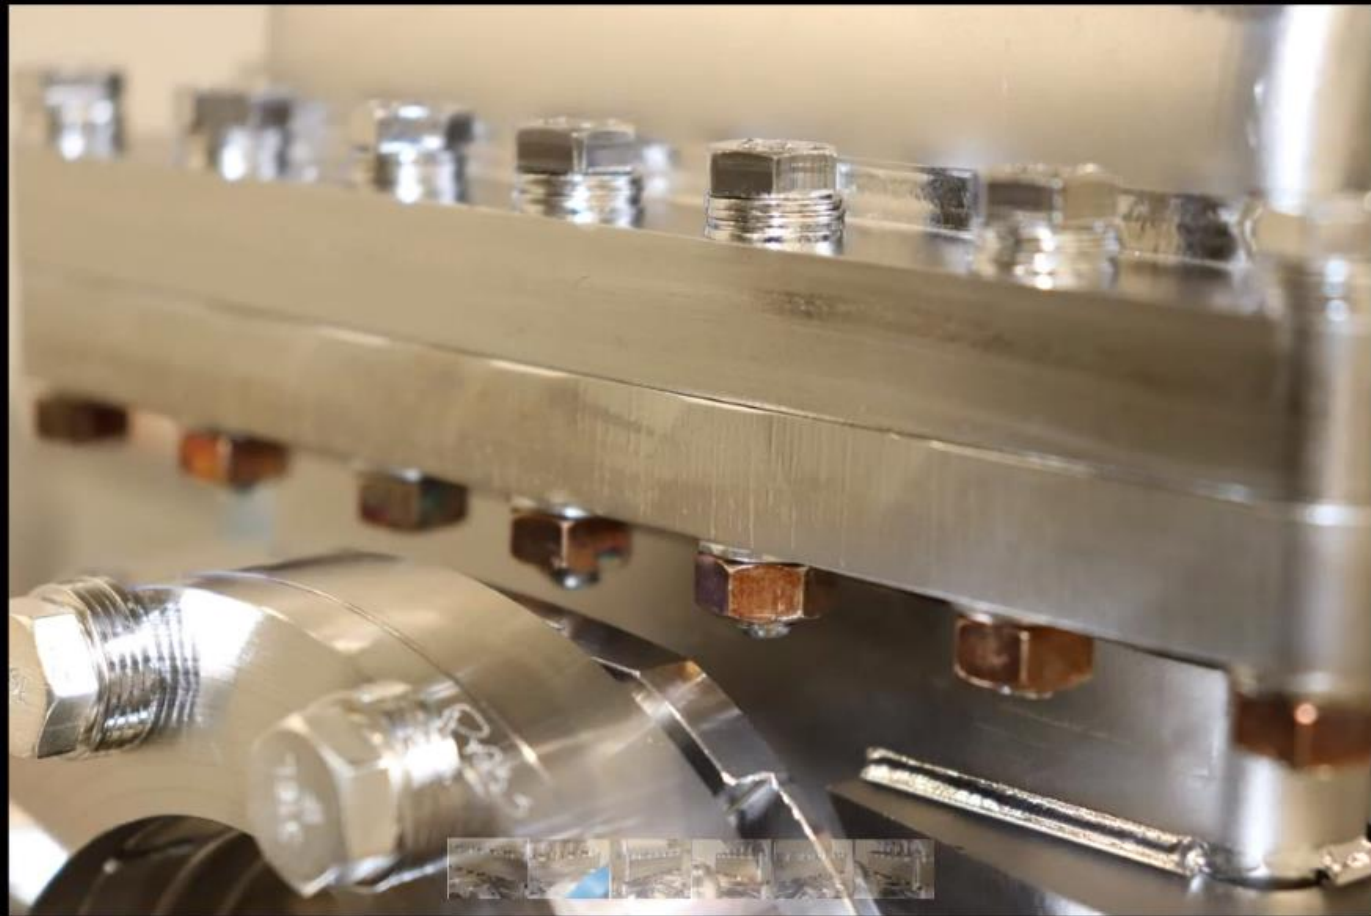
Good morning as discussed I torqued bolts and studs to 120 inch pounds this morning and re-tight checked we had no change in leak rate 210E-05 After the re-torque I notice and felt what appears to be the flange bulging out in line with the bolts and studs I have included pics to show what I mean along with pics from the other dogleg flange that isn't leaking to compare to.
