Current Status of the large GEM detector assembly

Zhigang Xiao

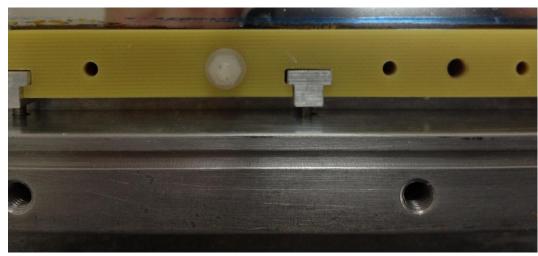
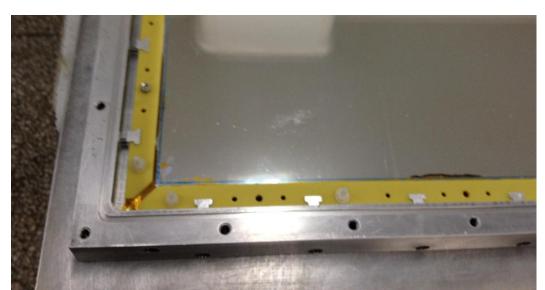
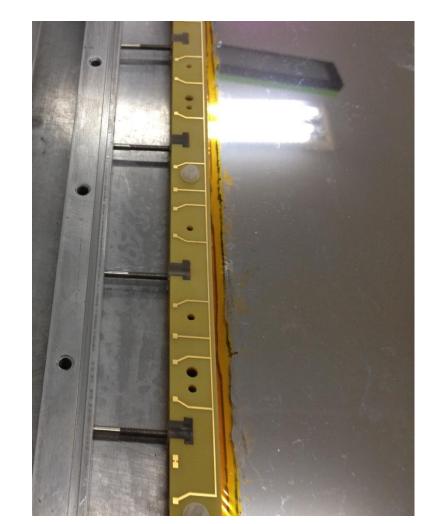
• Main modification is at the way of stretching the foil. Make a new foil stretching system. Try and test many times with thin mylar foils to get trained in the technique.

Using the previous way to assembly the large GEM detector, the flatness of the GEM foil can not be guaranteed and sparking occurs to damage the large GEM foil.

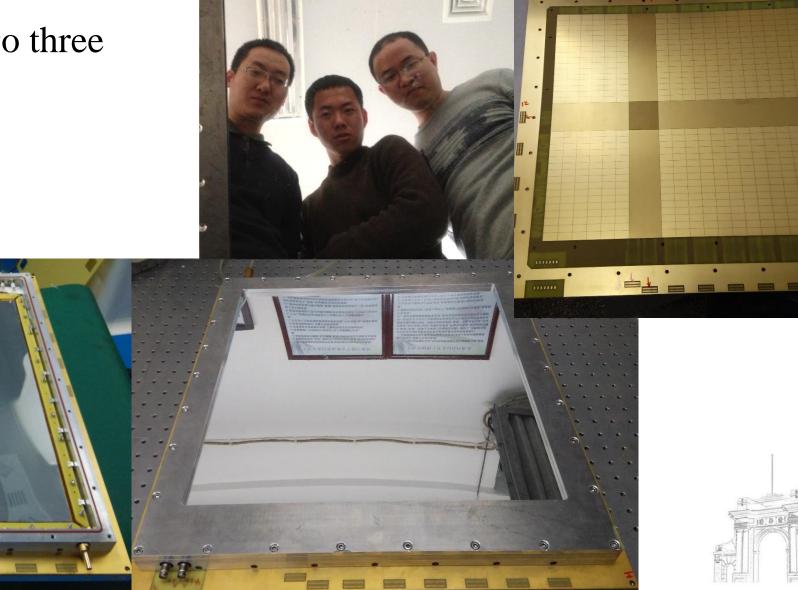
Single-Foil detector has been mounted

• Currently 2 Layers, go three layers in next week

\rightarrow A large are GEM detector (450mm*450mm) is assembled with 2 layers of GEM foil;

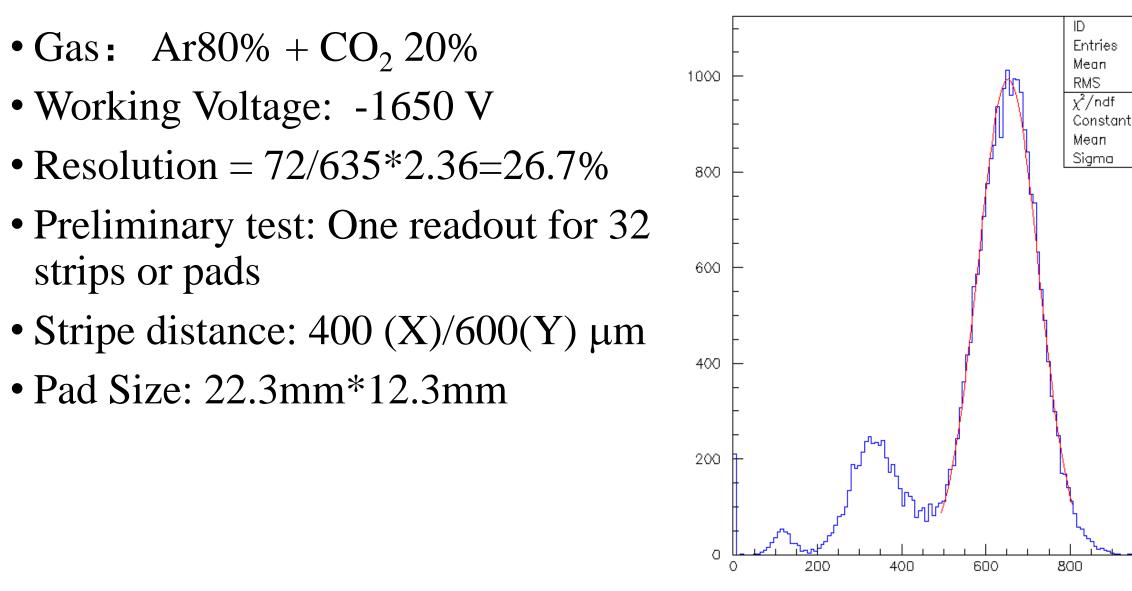
Energy Resolution Test

→Typical Energy Resolution is achieved, while the non-uniformity is still presented.

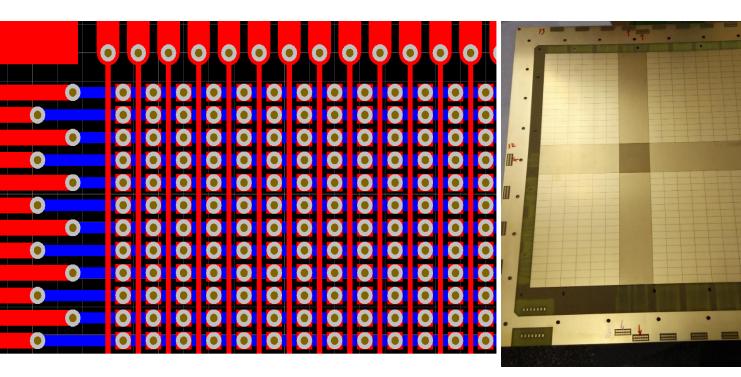
Uniformity Test

- Large non-uniformity, Strips see larger noise, while noise on pads are smaller.
- Detailed test required

Strip #	Peak	Sigma
3	653	72
5	560	81
<u>Z</u>	<u>549</u>	<u>74</u>
10	588	61
12	570	107
13	653	75
16	579	103
19	542	77
22	620	75
25	554	105
