Hall B - Solenoid Fast Dumps (Sep, 2017 to Feb,2018)										
Period	Fast Dump #	Date	Time	Tripped @ Current [A]	Cause	VT combination	Description	Threshold	Time Delay	Notes
Commissioning	1	9/12/2017	14:47	932	QD1 :Ch3	VT15+VT16+VT17+VT18+VT19	VT18 had voltage spike ~600 [mV] that generates VT8 (coil 3 quenching) went to ~ 2.3[V]	60 [mV]		
	2	9/12/2017	17:27	1014	QD1:Ch3	VT15+VT16+VT17+VT18+VT19	VT18 splice voltage spike ~125 [mV] which generated VT12 (coil 4 quenching) went to ~ 5.5 [V]	60[mV]		After this event on 09-15-2017- Magnet team decided to change PLC as primary protection system for VT splices. Thresholds changed for QDs 1/2 (Non coils VTs) and PLC comparators. QD VT splices threshols raised from 60 to 750 [mV] and trigger window from 0 to 999 [ms]
	3	9/13/2017	16:15	1035	QD1:Ch1	[VT11+VT12+VT13+VT14] - [VT5+VT6+VT7+VT8+VT9+VT10]	Differential of addition of all VT combinations in QD1:Ch1 generated Fast dump	60[mV]

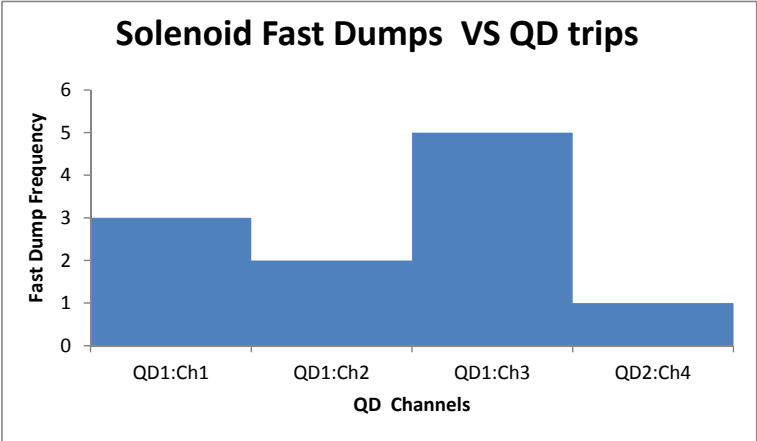
Incident QD Channels	Frequency
QD1:Ch1	3
QD1:Ch2	2
QD1:Ch3	5
QD2:Ch4	1
Total incidents due to QDs	11
